BULLETIN

from the ATARI CUSTOMER SERVICE DEPARTMENT

B-0011

TANK "JITTER" PROBLEM, MONITOR MODIFICATION

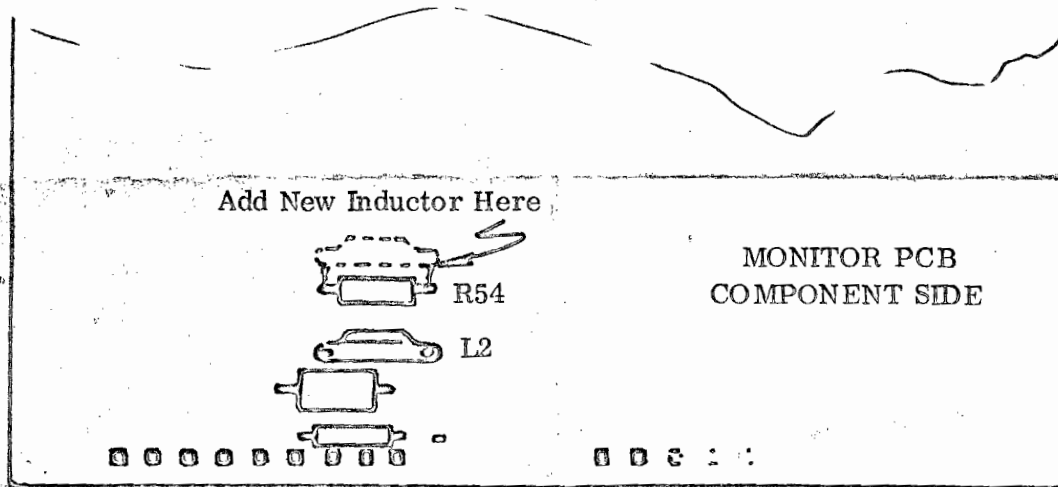
Figure 1

The problem of jitter in the upper portion of the display, particularly evident in TANK II, has been carefully evaluated by the Atari Engineering Department. The most practical answer has been found to be a minor modification to the monitor printed circuit board, involving the addition of a small inductor. The necessary component (inductor) is being supplied by Atari to purchasers of the Tank games, without charge, and should be installed into the monitor printed circuit board as described below.

1. Looking at the top (component side) of the monitor printed circuit board, (see Figure 1), near the rear edge and left of center, locate the two components, inductor L2 and a 39 ohm resistor R54. These components are installed in parallel.
2. The modification consists of adding an inductor (supplied with this bulletin) in parallel to the existing components, L2 and R54. For greatest convenience, therefore, it is only necessary to solder the new inductor directly across R54 on the component side of the circuit board.
