Service Bulletin N° 86

SUBJ: **INDEPENDENCE DAY** Potential Balltrap in the Plastic Under-Trough

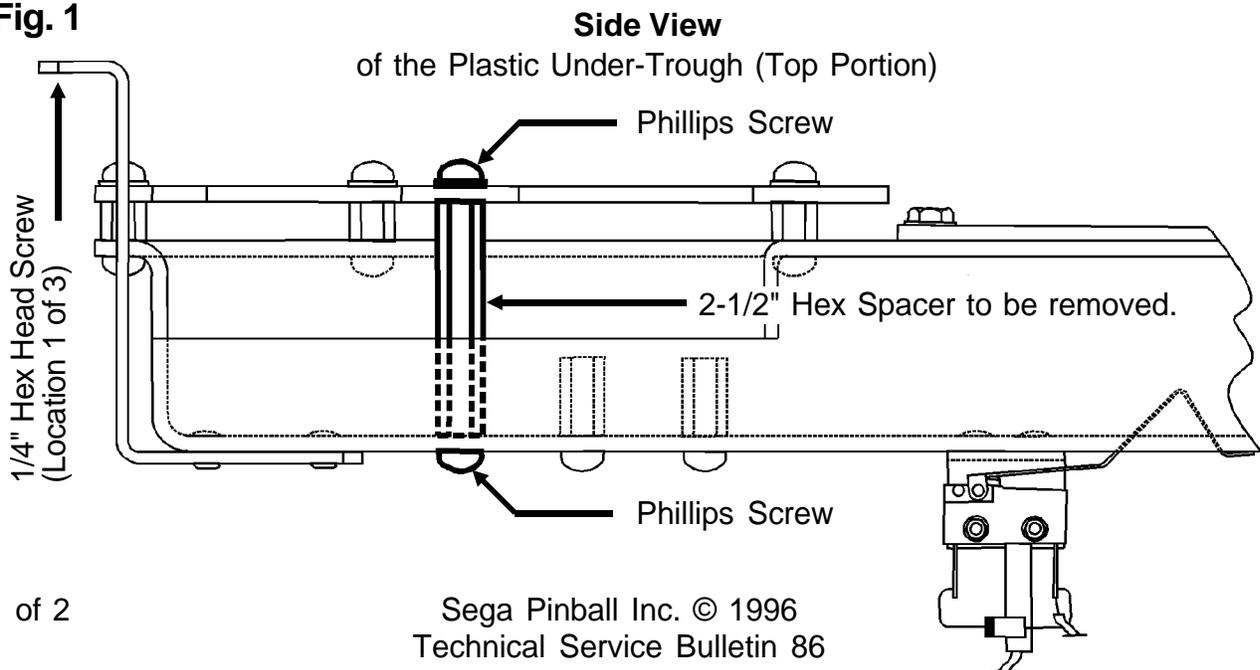
SYMPTOM: Balls get trapped in the Plastic Under-Trough Ramp beneath the *Alien Head*.

CAUSE: We have found a **potential** for a balltrap between the 2-1/2" Hex Spacer and the back wall of the Under-Trough because of normal variations in vacuum-formed plastic ramps (see Fig. 1 below).

SOLUTION: Remove the Plastic Under-Trough Ramp Assembly by removing the three 1/4" Hex Head Mounting Screws. Remove the two Phillips Screws and the 2-1/2" Hex Spacer (see Fig. 2 on the next page). Reattach the Under-Trough.

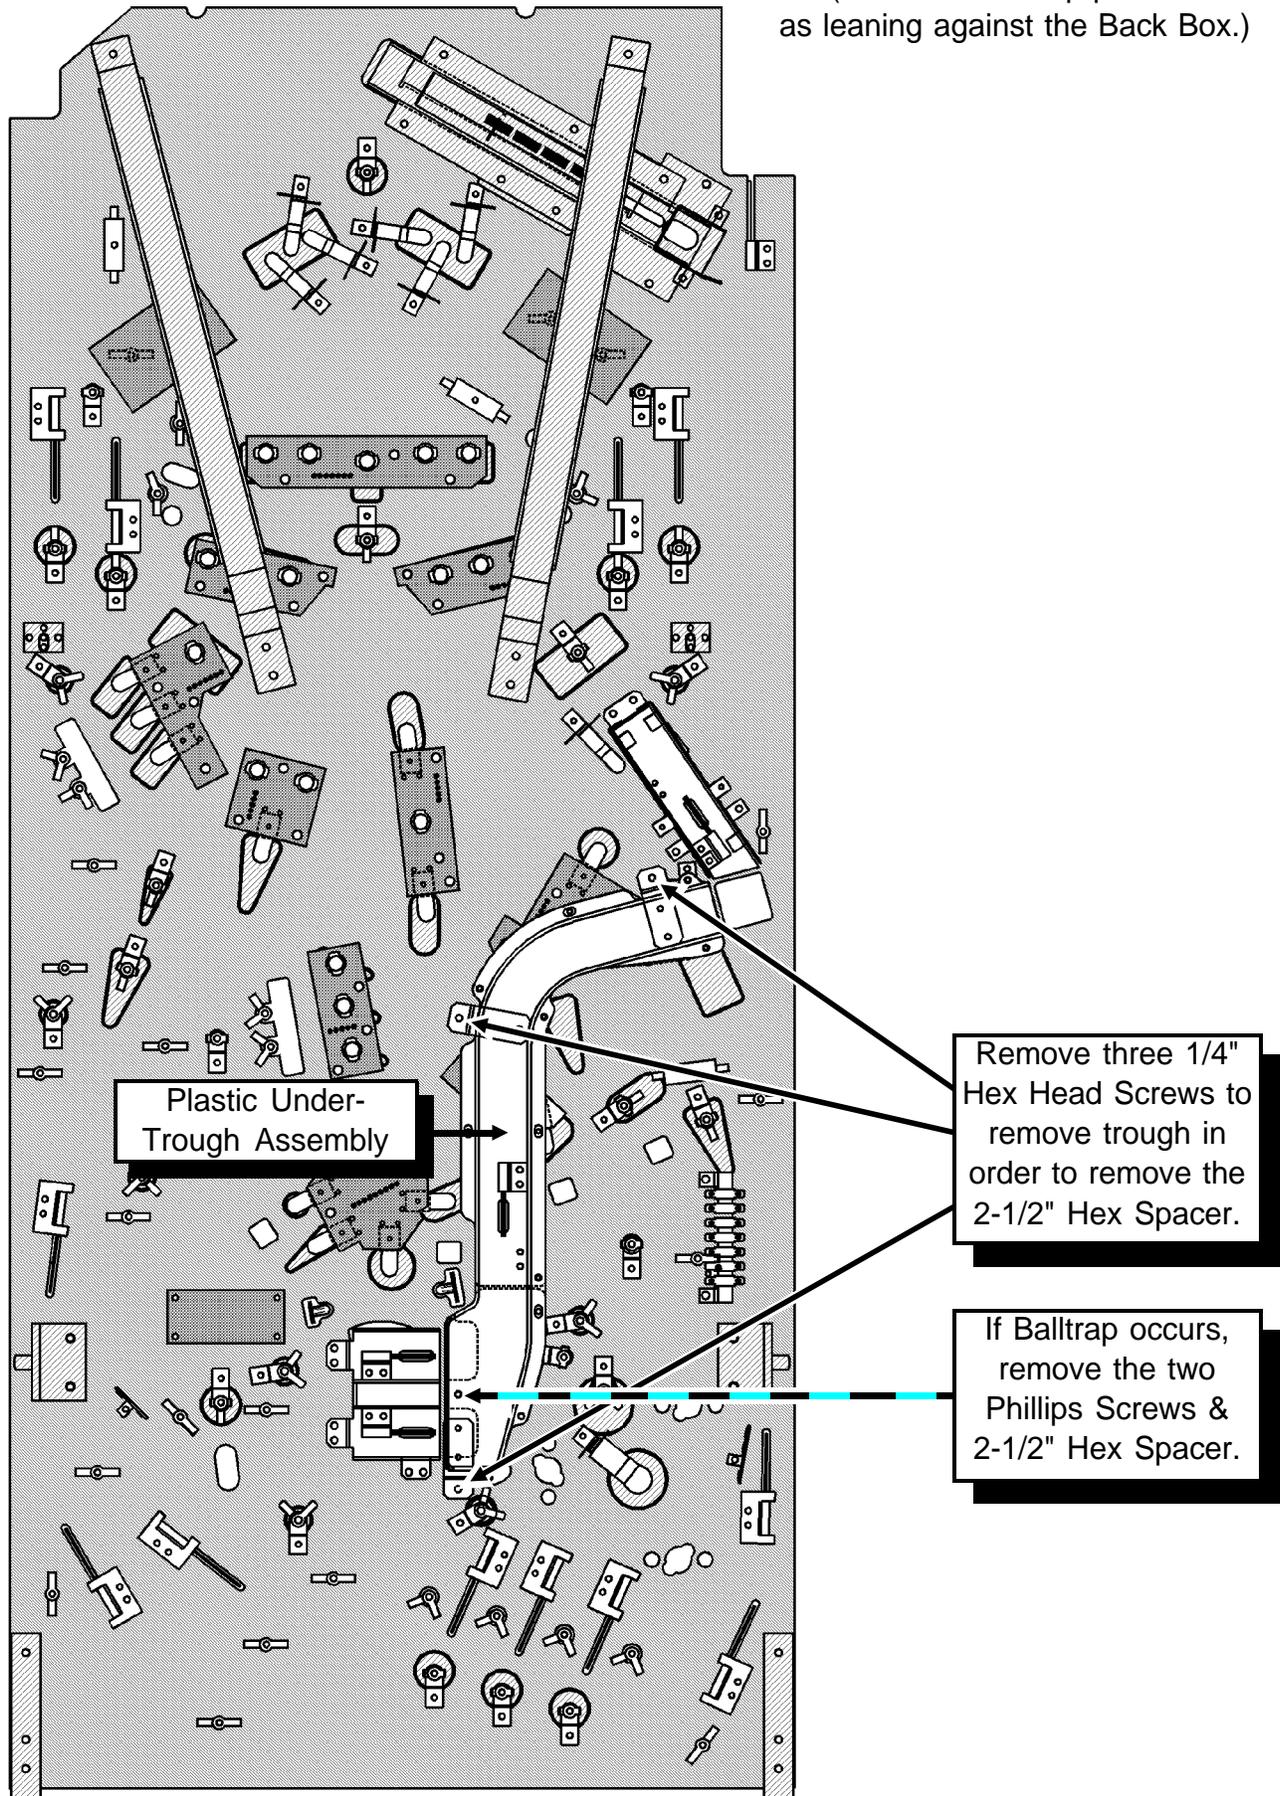
Fig. 2

Bottom View of the ID4 Playfield
(as seen in the up position
as leaning against the Back Box.)

NOTE: This spacer was there strictly to give **additional** support to the clear plastic cover over the top of the trough. *Removing it will not create any problems.*
