# Service Bulletin N° 97

DATE: April 8, 1997

SUBJ: X-Wing Motor Bushing

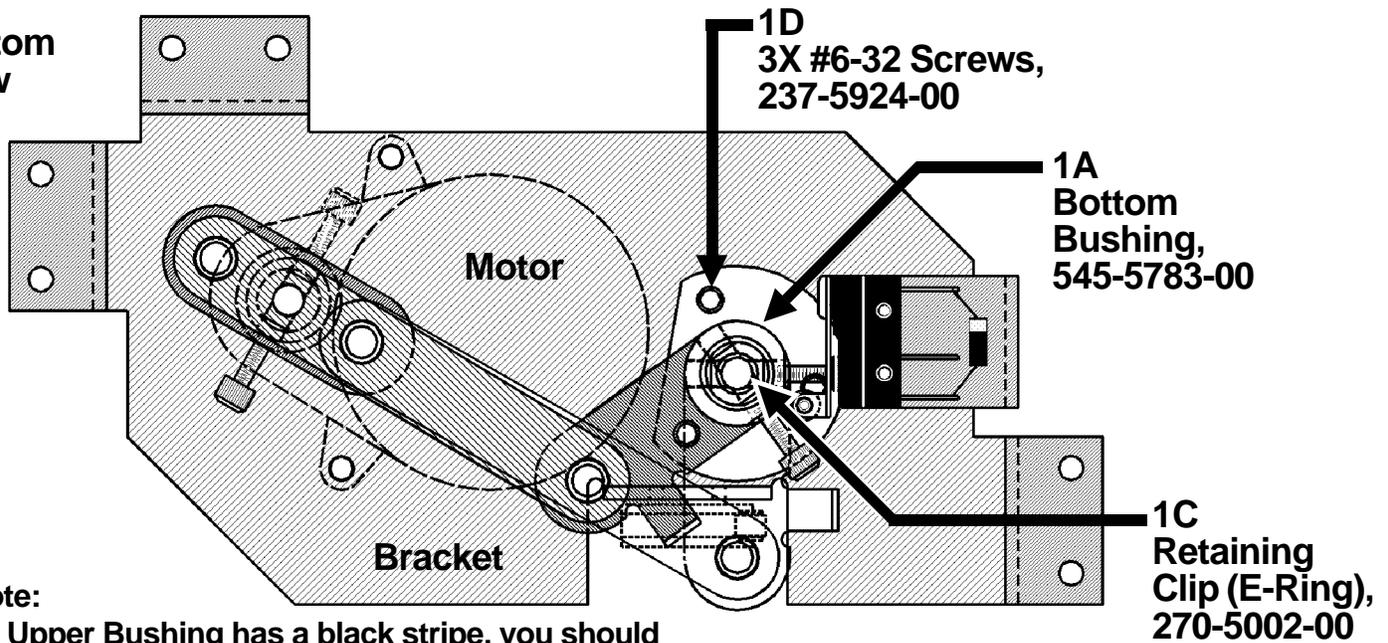
Bottom View

Due to slight variances in spotting the X-Wing Assembly while mounting it to the playfield, the shaft bushings (**See Fig. 1**) can cause some binding to the motor shaft. Increasing the inside diameter of *either* shaft bushing (**See Fig. 1A & 1B**) will correct this problem. For simplicity in this correction we recommend fixing the bottomshaft bushing (**See Fig. 1A**). (**See Note below.**)

\* Note:  
If the Upper Bushing has a black stripe, you should not experience any "stuck-state" symptom and no further update procedure should be required.

- ① Locate the X-Wing Motor Assembly Bottom Shaft Bushing, 545-5783-00, on the bottom side of the playfield (**See Fig. 1A**).
- ② Locate and remove the Retaining Clip (E-Ring), 270-5002-00, located at the base of the X-Wing Shaft (**See Fig. 1C**).
- ③ Remove the three (3) #6-32 X 1/2" HWH TF Mounting Screws, 237-5924-00, securing the Bushing to the X-Wing Motor Bracket (**See Fig. 1D**).
- ④ Remove the Bushing from X-Wing Motor Bracket (**See Fig. 1A**). Using a #G or a 6.6mm Drill Bit, enlarge the existing Bushing Shaft Hole. Reassemble.

If you do experience the "stuck-state" symptom, simply remove the bottom shaft bushing (removal of the Retaining Ring & 3 Screws is required) and drill the existing Shaft Hole with a #G or 6.6mm Drill Bit and reassemble.

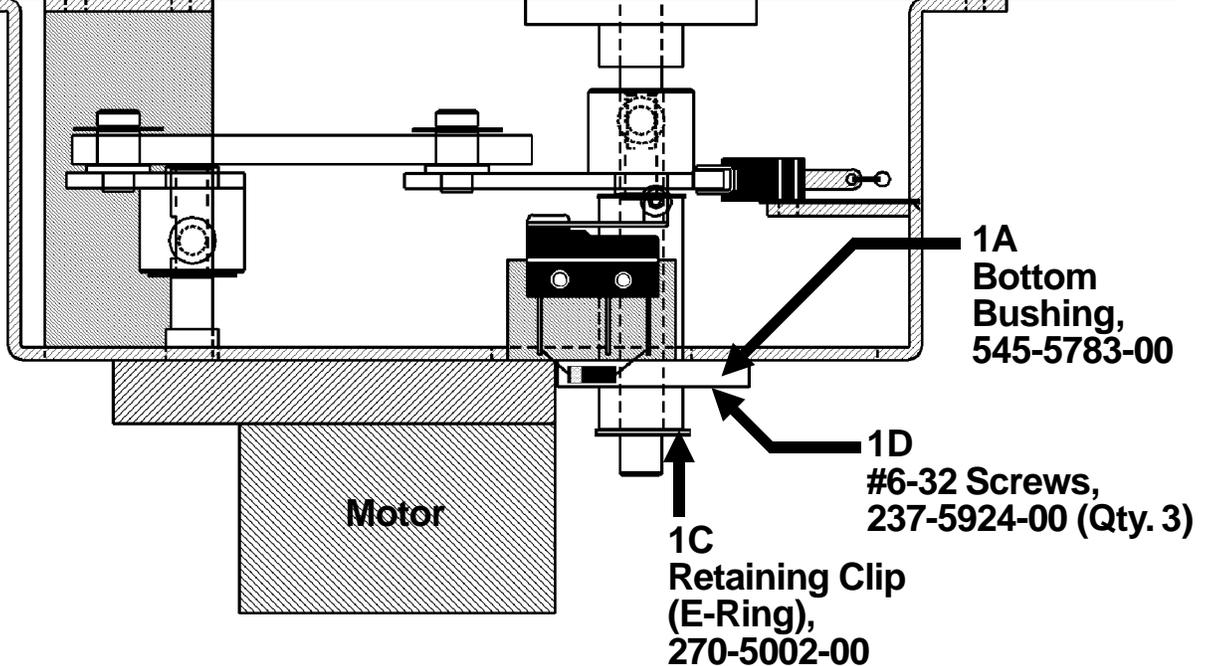
Side View

As stated, there are 2 X-Wing Shaft Bushings, one (1) on the X-Wing Motor Assembly (**See Fig. 1A**) and one (1) on the Upper Motor Shaft on the playfield side (**See Fig. 1B**). **All games made after Serial N° 138041 have been modified and should not experience this "stuck-state" symptom.** The bushing mounted on the playfield side will have a black stripe indicating this (**See Fig. 1B**). **Unless your game is experiencing the above symptoms disregard the above procedure.**
