SERVICE BULLETIN

SEGA BASS FISHING UPRIGHT

PROBLEM: The Handle for BASS Fishing's Upright Cabinet is breaking due to abusive load/torq applied to the Handle Assy.

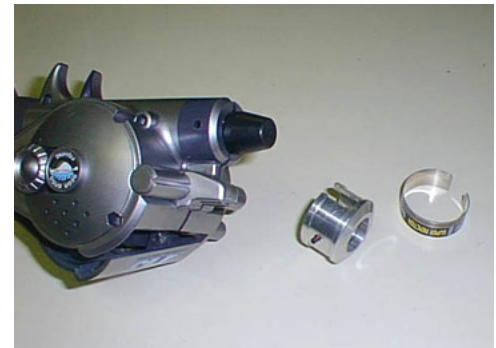
Image showing Front Ring and Front Ring Spring.

- ① First remove the 7 screws securing the Handle Assy together.
NOTE : It will not be necessary to remove the Handle Assy from the cabinet to perform this upgrade.
- ② Remove the Front Ring Spring from the Front Ring. This will reveal the 2 set screws imbedded on the Front Ring itself.
- ③ Remove the 2 set screws from the Front Ring and remove the Front Ring from the Handle Assy.
- ④ Separate the 2 halves of the Handle Assy to expose the interior of said assy.

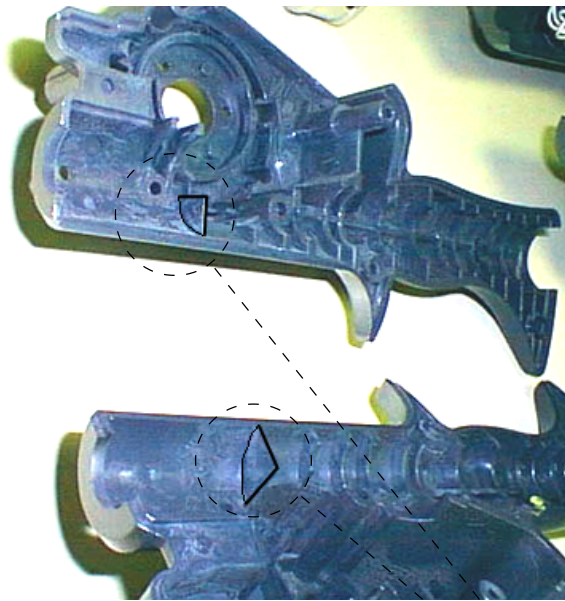
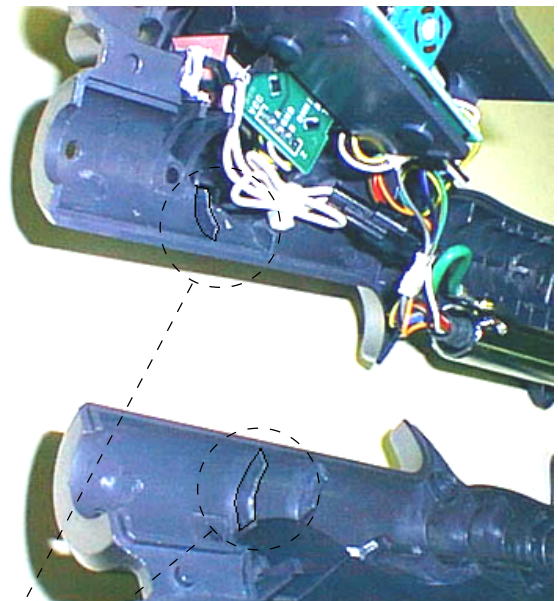
View of the inner portion of the Handle Assy housing. Shown with and without the ribbed portion cut away to allow room for the reinforced metal tip.

- 5 Next cut away a ribbed portion of the Handle Assy as shown in photos ABOVE to allow enough room for the new piece to be installed.
- 6 Replace the black Rod Tip with the reinforced metal Rod Tip.

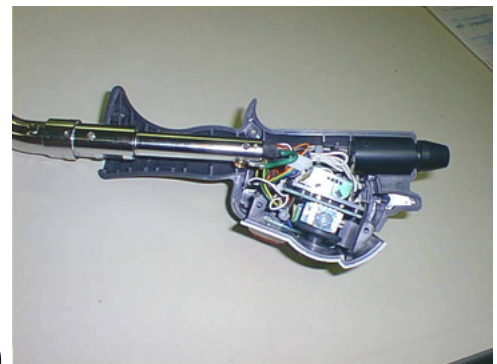
Image showing original black tip.

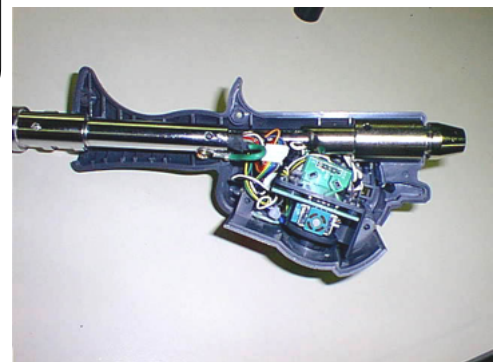
Image showing reinforced metal tip.

SOLUTION: The Handle Assy can be refitted with a support tube capable of dispersing the force exerted on it by customers in the field.

NOTE: When installing the reinforced metal Rod Tip, ensure the groove portion of Rod Tip faces 'up' towards sensor bd. and rear portion of groove slips into the top portion of Handle Shaft to allow maximum clearance of wire assy. Failure to observe this may cause wire damage, and/or short circuit.
