Subject : Conversion of Pole Position II boards from Japanese to English.

Subject: Pole Position M.O. Problems

To: Darl Davidson
From: Sam Deus *Sam*
Subject: Pole Position P.C. Board Problems

Pole Position Video Board Manufacturing Defects

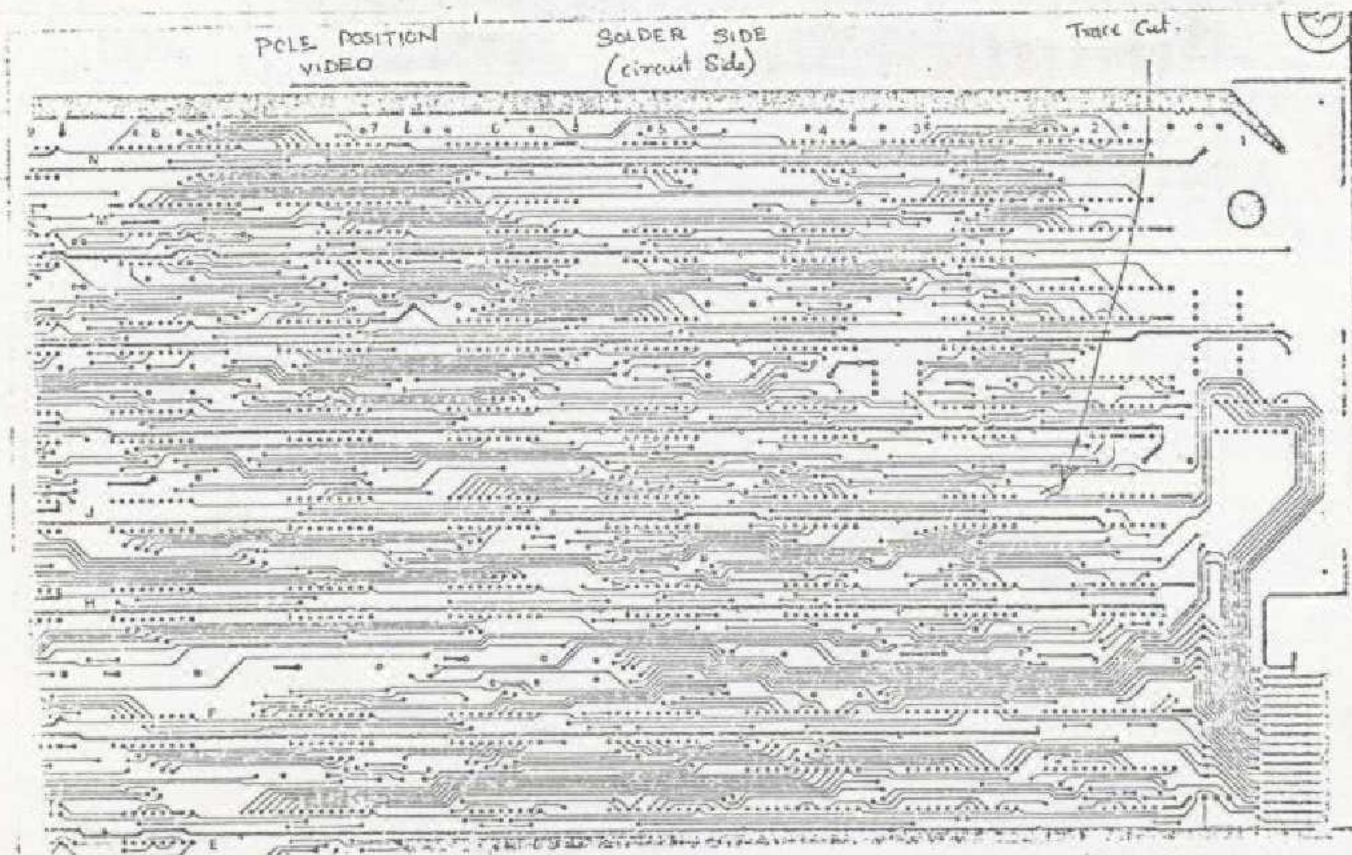
The principle problem with the Pole Position Video boards was a masking error; VSYNC was being disrupted by a signal which was being output from pin 8 of IC 2J. Pin 8 of 2J had to be cut & lifted from the feed thru pad because the VSYNC trace was erroneously masked & subsequently etched from pin 17 of IC 2F (custom IC 07) to pin 8 of IC 2J (74LS10) which is supposed to be an unused output, not an input. See page 3 of 10 (Video PC BD schematics)
