TECH TIP

from the ATARI FIELD SERVICE DEPARTMENT

ROADBLASTER

Road Blaster Vertical Roll problem

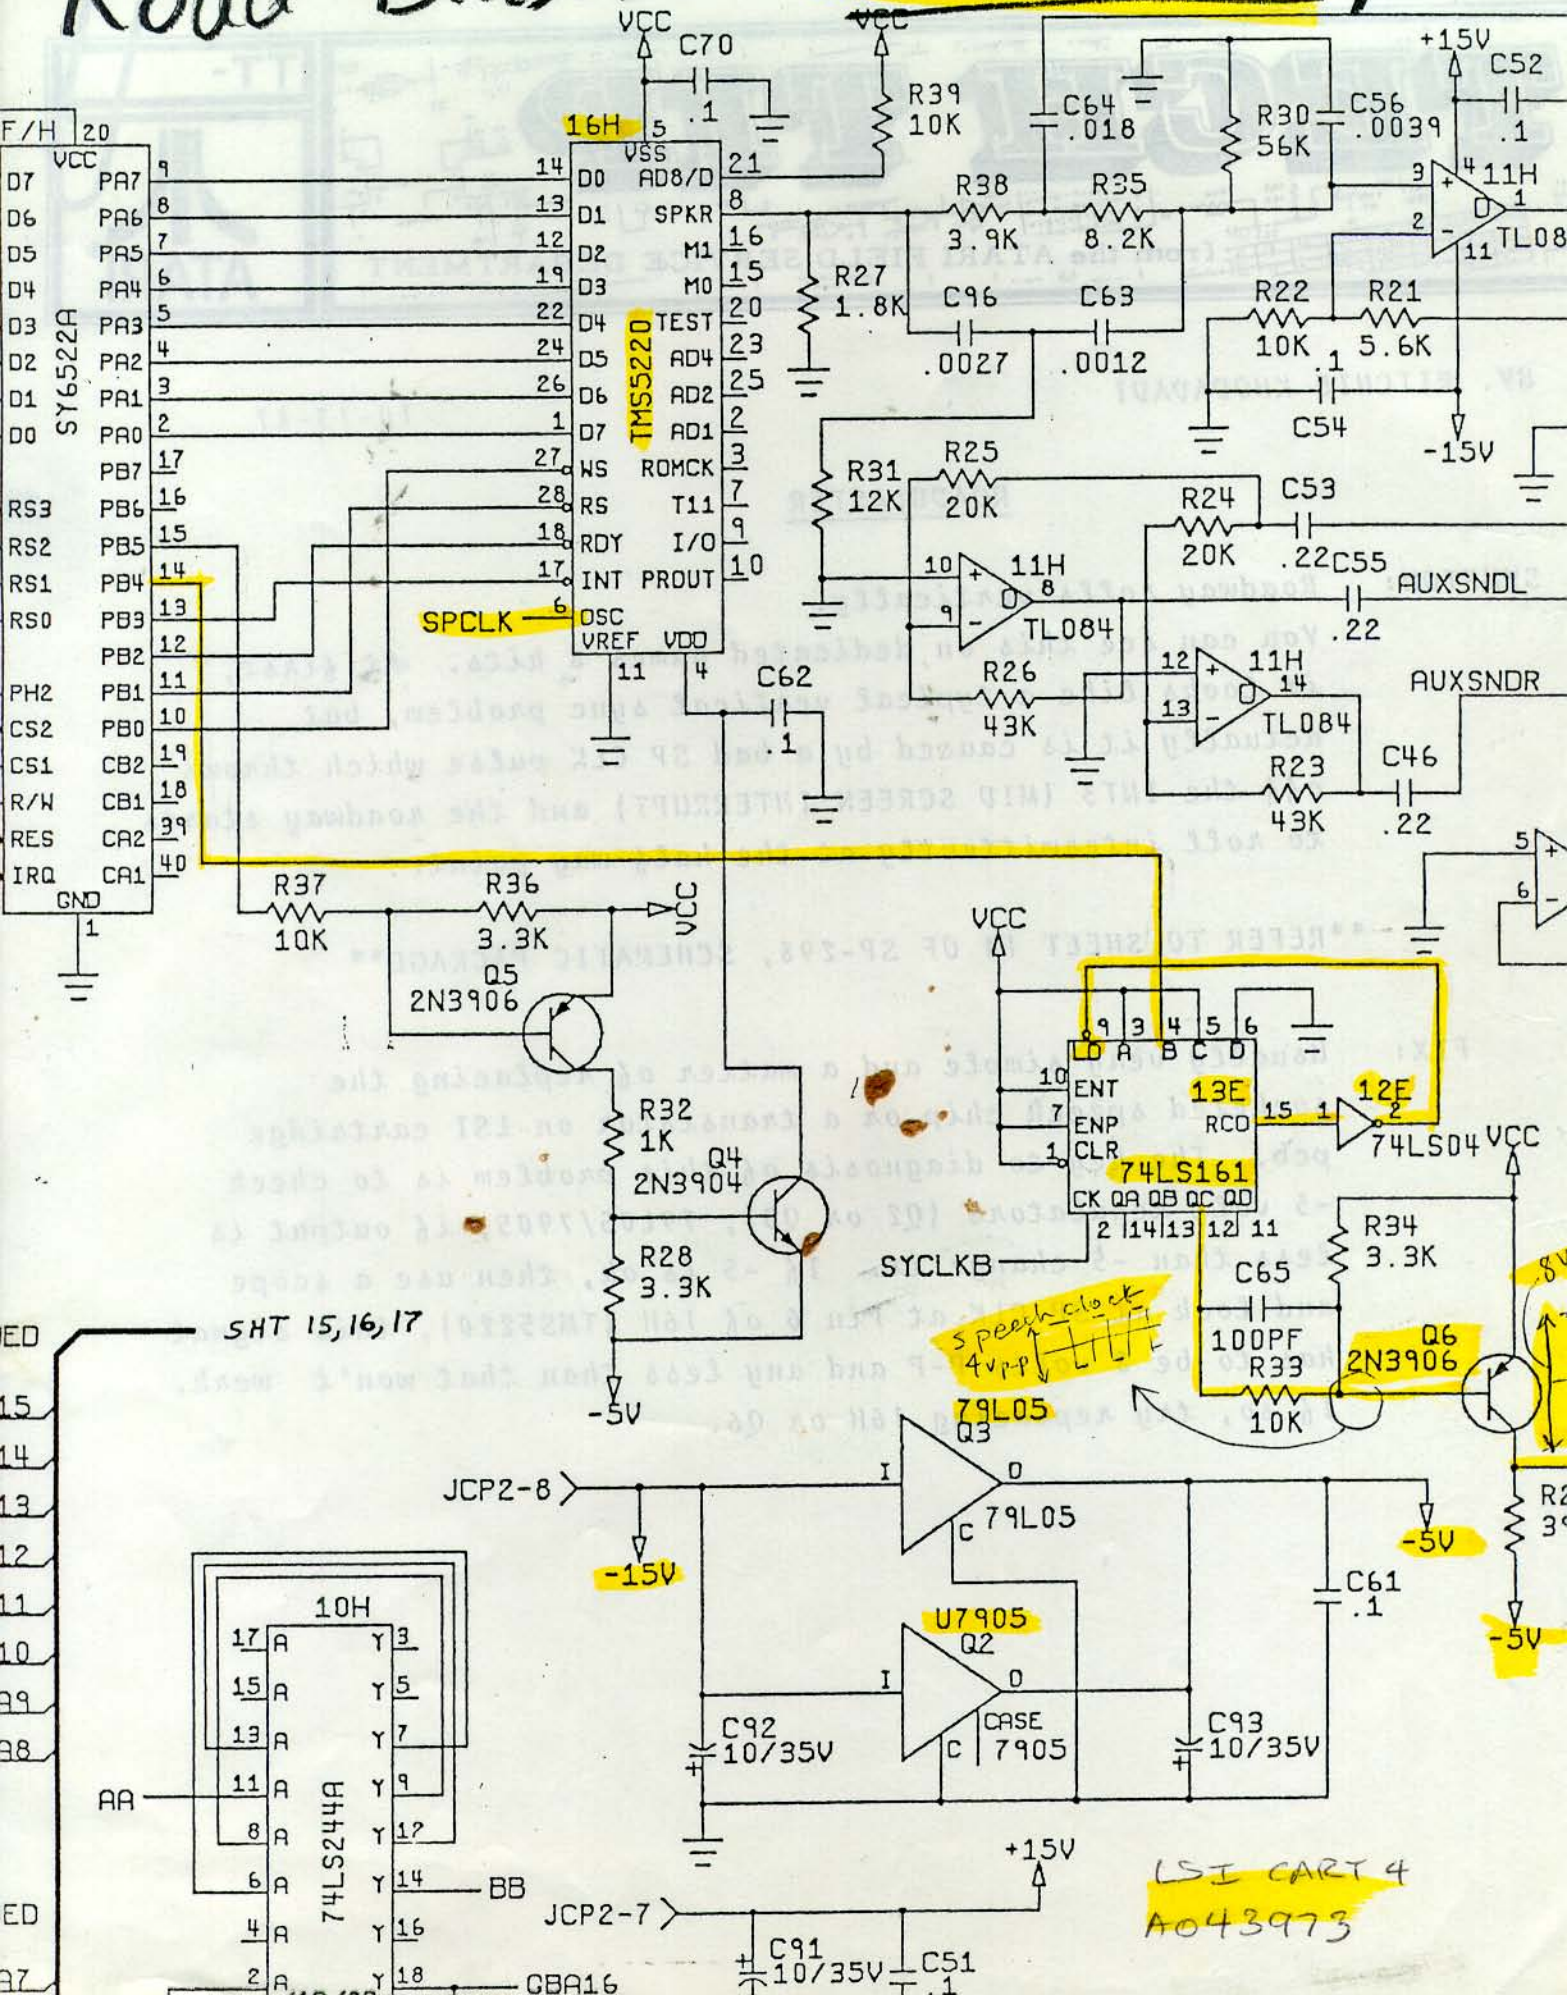
SYMPTON: Roadway rolls vertically.
You can see this on dedicated games & kits. At first, it looks like a typical vertical sync problem, but actually it is caused by a bad SP CLK pulse which throws off the INT3 (MID SCREEN INTERRUPT) and the roadway starts to roll intermittently at the half-way point.

FIX: Usually very simple and a matter of replacing the socketed speech chip or a transistor on LSI cartridge pcb. The key to diagnosis of this problem is to check -5 volt regulators (Q2 or Q3), 79L05/7905, if output is less than -5 change it. If -5 is ok, then use a scope and look at SP CLK at Pin 6 of 16H (TMS5220), this signal has to be 8 volts P-P and any less than that won't work. If so, try replacing 16H or Q6.
