# SERVICE TIPS

82-8

GAME: GRAND CHAMPION

SUBJECT: ATTACHED IS A BLOCK DIAGRAM FOR GRAND CHAMPION UPRIGHT.  
WE HOPE THIS WILL ASSIST YOU IN TROUBLESHOOTING THE GAME.  
IN EACH BOX THERE ARE NUMBERS AND LETTERS WHICH INDICATE  
THE CHIP LOCATION ON THE BOARD.

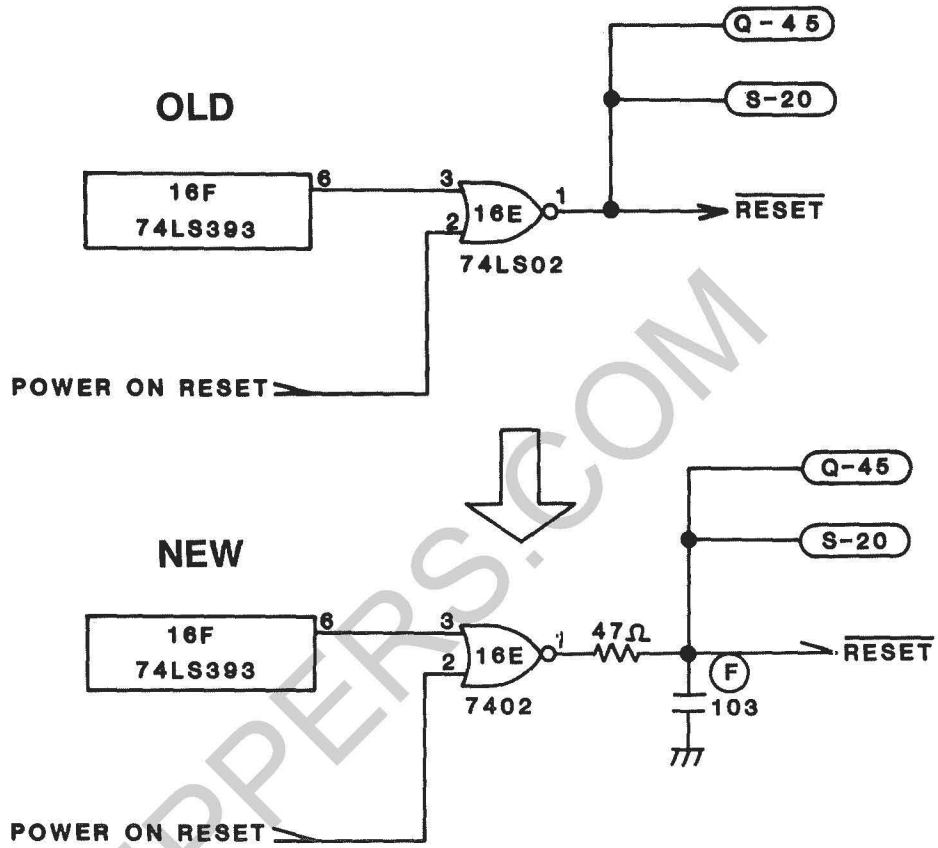
FIGURE 1

**SUBJECT:** INTERMITANT RESET

**SOLUTION:** ADD PULL-UP RESISTOR AND FILTER CAP

**PROCEDURE:** CUT ETCH COMING FROM IC E16 PIN 1 (REFER TO FIGURE 2) ADD A 47 OHM RESISTOR BETWEEN PIN 1 AND THE FEED THROUGH (REFER TO FIGURE 2) ADD THE .01  $\mu$ F CAPACITOR BETWEEN THE FEED THROUGH AND GROUND.

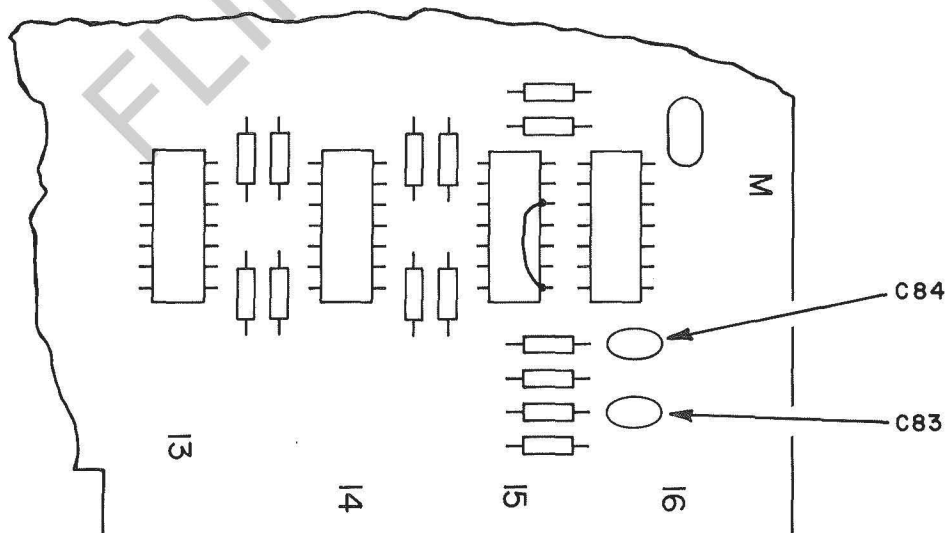
PROBLEM: COIN NOT ALWAYS REGISTERS

SOLUTION: CHANGE VALUE OF CAPACITORS FOR BETTER REACTION.

PROCEDURE: REPLACE C83 AND C84 WITH 1uf CAPACITOR (REFER TO FIGURE 1).

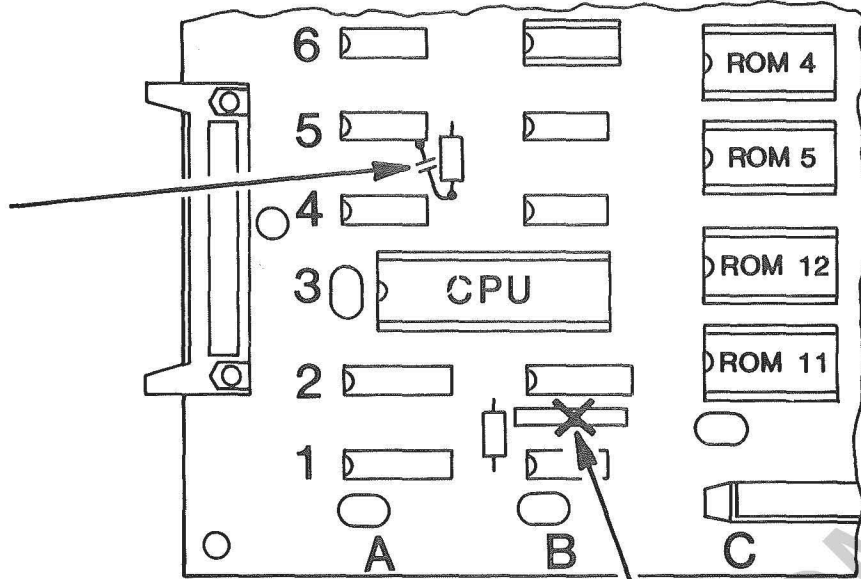
FIGURE 1

SUBJECT: INTERMITANT LOCK-UPS

SOLUTION: IMPROVE DATA LINES RESPONSE AND IMPROVE CLOCK INPUT TO BOTH CPU'S.

PROCEDURE: REMOVE THE RESISTOR BLOCK ON THE CPU BOARD LOCATED AT LOCATION 1.5B (REFER TO FIGURE 1). ADD A 330pf CAPACITOR BETWEEN THE 220 OHM RESISTOR AND GROUND AS SHOWN IN FIGURE 1.

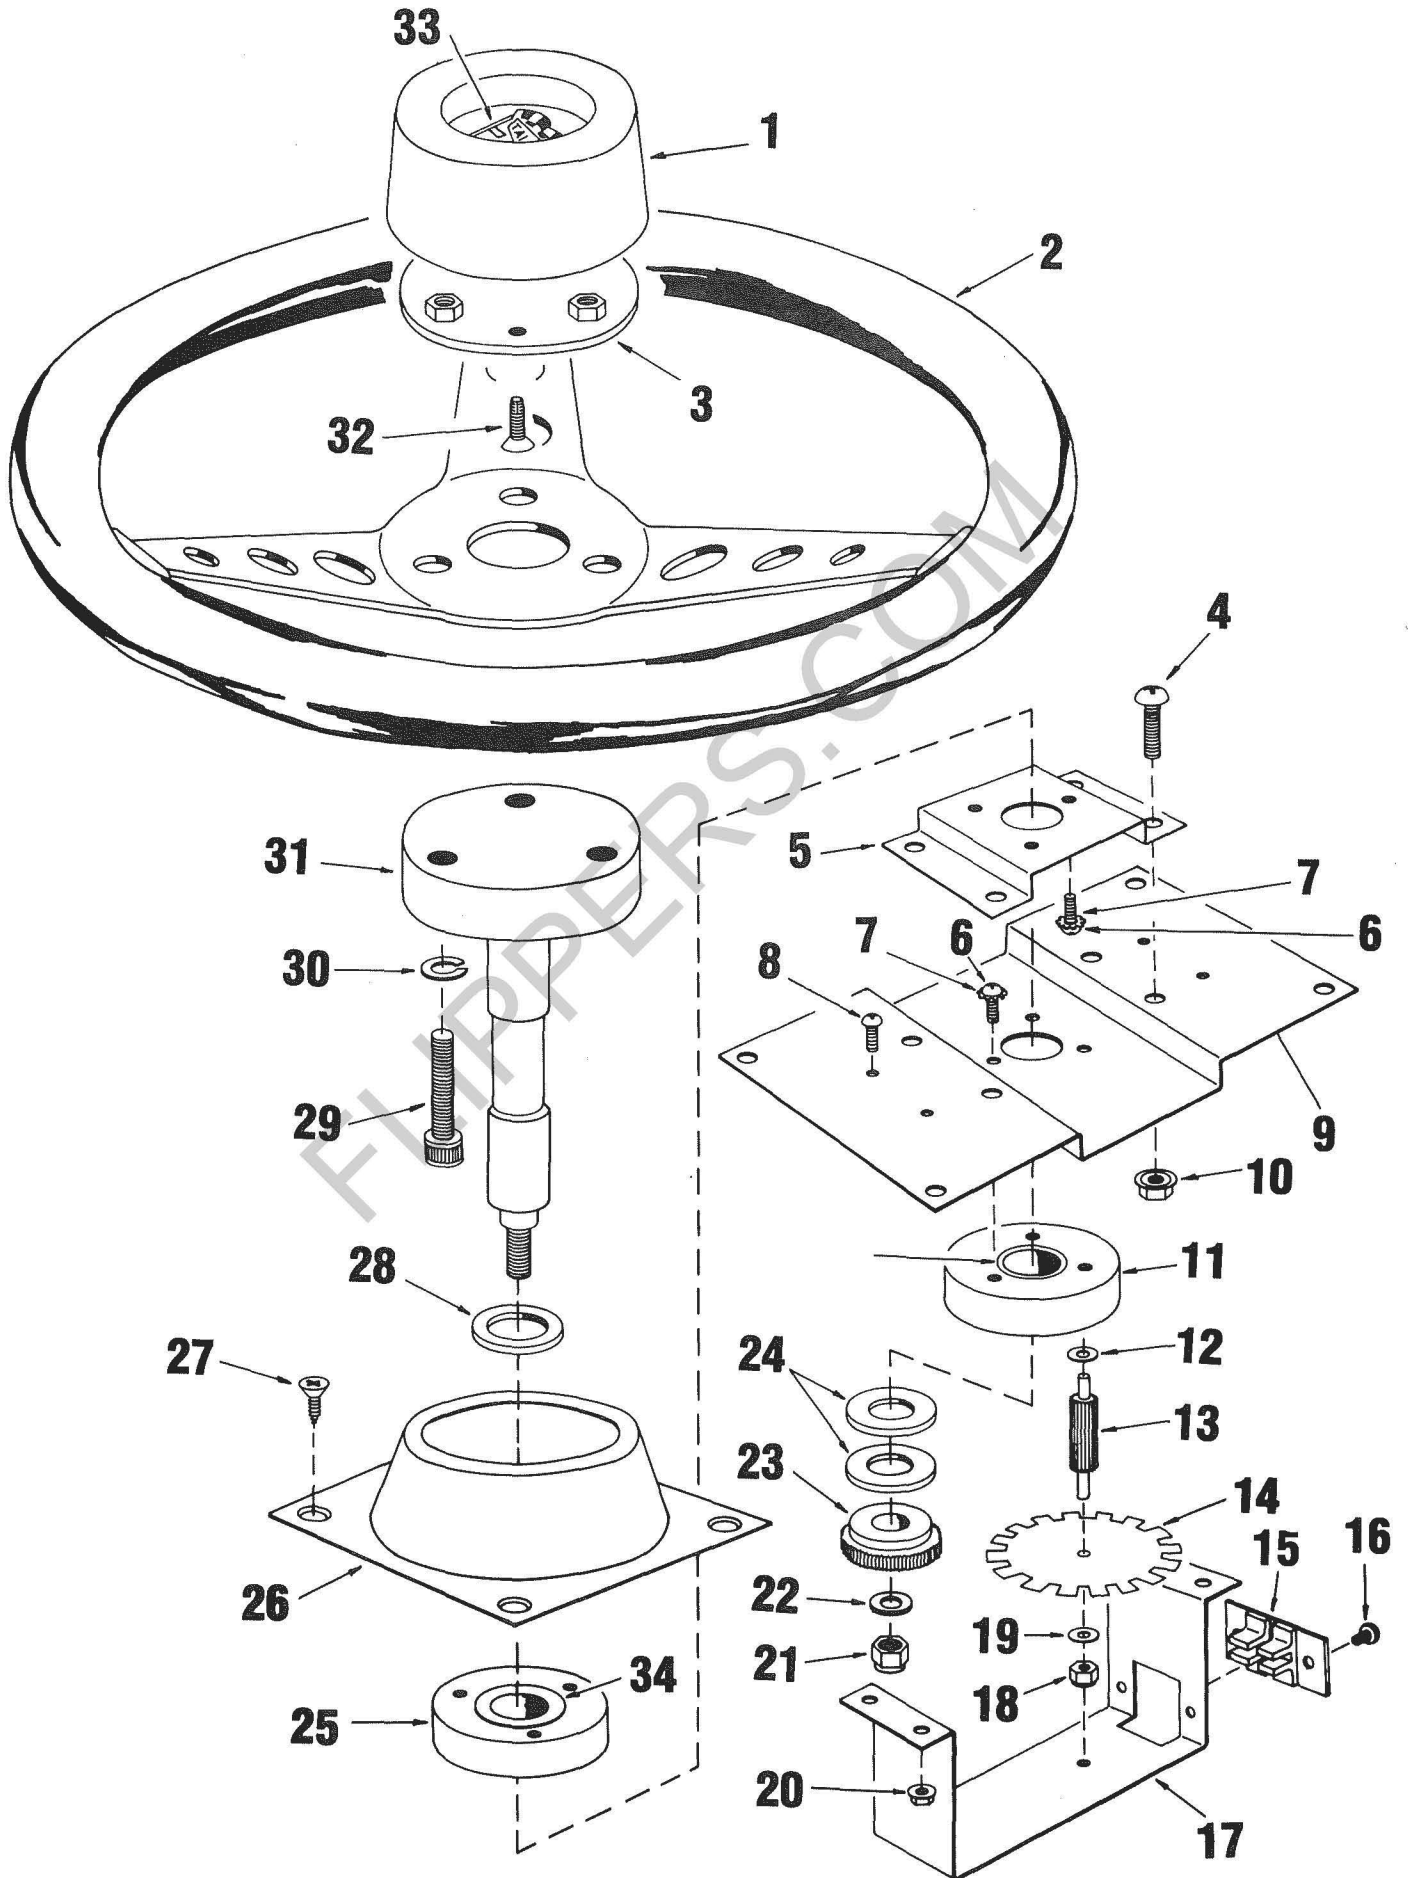
FIGURE 1

SUBJECT: STEERING WHEEL WOBBLER AFTER SOME USE.

IN ORDER TO DETERMINE IF THIS PROCEDURE IS NECESSARY, REMOVE THE CONTROL PANEL AND TEST TO SEE IF HUB (A) ITEM 11 IS ABLE TO MOVE IN ANY DIRECTION. IF IT DOES MOVE, THE FOLLOWING PROCEDURE NEEDS TO BE USED IN ORDER TO AVOID UNNECESSARY WEAR OF THE SHAFT.

SOLUTION: ADD SCREWS TO THE HUB (A).

IN ORDER TO INSTALL THE MISSING SCREWS IN HUB A YOU MUST FIRST DISCONNECT THE PHOTO SENSOR PCB PLUG AND MOVE IT OUT OF THE WAY. LOOSEN AND TAKE OFF THE FOUR FLANGE NUTS (ITEM 20) HOLDING DOWN THE SENSOR BOARD BRACKET. UPON REMOVING THE SENSOR BOARD BRACKET, THE PULSE CAM AND GEAR ( ITEMS 13 & 14) SHOULD COME LOOSE ALONG WITH IT.

LOOSEN AND REMOVE THE SELF LOCKING NUT (ITEM 21) HOLDING DOWN THE STEERING SHAFT. AFTER REMOVING THE LOCKING NUT REMOVE THE SPRING WASHER (ITEM 22), THE GEAR (ITEM 23), AND THE SPACE WASHER (ITEM 24). THE STEERING WHEEL AND SHAFT IS LOOSE NOW AND CAN BE PULLED OUT OF THE CONTROL PANEL

NEXT, REMOVE THE FOUR OUTER HUB BASE NUTS WITH THEIR ADJOINING WASHERS. ALSO, REMOVE THE EARTH GROUND STRAP CLOSEST TO THE SHIFTER. LOOSEN AND REMOVE THE FOUR FLANGE NUTS (ITEM 10) ON THE HUB BASE. NOW THE HUB BASE (ITEM 9) AND HUB A (ITEM 11), AND CAN BE REMOVED FROM THE CONTROL PANEL.

ADJOIN MISSING PAN HEAD SCREWS (ITEM 6) AND STAR WASHER (ITEM 7) TO THE HUB A. A NOTE OF CARE IS ADVISED IN ADJOINING THE HUB BASE TO THE CONTROL PANEL. THE HOLE FOR THE PULSE CAM AND GEAR SHOULD BE PUT CLOSEST TO THE GEAR SHIFTER, AS THE PLUG FOR THE PHOTO SENSOR WILL NOT REACH OTHERWISE.

WHEN REASSEMBLING THE STEERING WHEEL SHAFT TO THE CONTROL PANEL THERE MUST BE TWO SPACER WASHERS (ITEM 28) AFFIXED TO THE FRONT PART OF THE SHAFT. ON THE BACK SIDE OF THE SHAFT THERE SHOULD BE ONE SPACER WASHER (ITEM 24) AFFIXED TO THE BACK OF THE SHAFT. SOMETIMES TWO SPACE WASHERS MUST BE USED. EACH STEERING WHEEL WILL VARY DUE TO THE WEAR. IF TWO WASHERS ARE USED THE STEERING WHEEL MAY SEEM TIGHT AT FIRST, BUT LOOSENING THE SELF LOCKING NUT (ITEM 21) AN 1/8 OF A TURN AT A TIME WILL LOOSEN THE STEERING WHEEL.

WHEN ASSEMBLING THE PULSE CAM AND GEAR IN THE HOLE PROVIDED IN THE HUB A, PROPER CARE SHOULD ALSO BE TAKEN IN THAT THE PULSE CAM IS IN THE MIDDLE OF THE PHOTO SENSOR, NOT TOUCHING EITHER OF THE EDGES. THIS CAN BE DONE BY ADJUSTING THE SENSOR BOARD BRACKET (ITEM 17) AND TIGHENING THE FLANGE NUT (ITEM 20), MAKING SURE THE GEAR IS PERPENDICULAR TO HUB A (ITEM 11).
