SERVICE BULLETIN

GAME: Secret Service

#010

SUBJECT: BallEater Adjustments

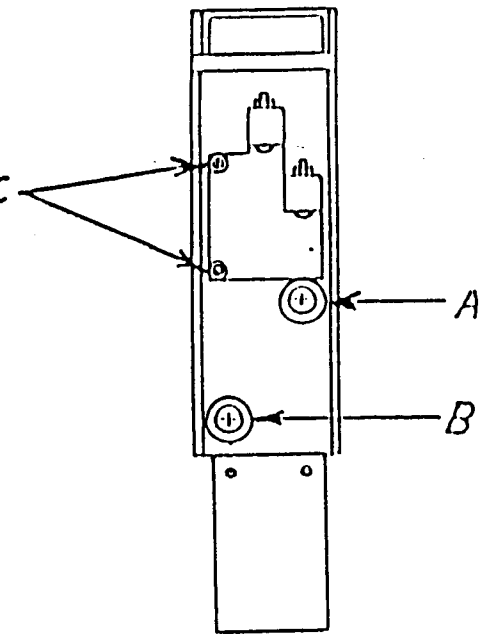
FIGURE 1

PROBLEM: Inadequate Tolerances on the Assembly

3. Remove 10 turns from the extension spring (fig. 2A).
4. Remove rubber stop from the base of the assembly (fig. 2B).
5. Remove flat washer and star washer from the second screw from the bottom of the housing (fig. 1A).

6. Loosen the two screws holding the switch assemblies (fig. 1C) and the two screws holding the coil assembly bracket (fig. 1A & B).
7. With the ball eater in the down position adjust the coil assembly bracket so the top of the ball eater cube is even with the top edge of the housing (fig. 3A).

8. Tighten the two screws holding the coil assembly bracket (fig. 1A & B).
9. Adjust the switch bracket assembly, so when the ball eater comes down the lower switch "makes" slightly before cube bottoms out (fig. 3B). This allows a wiping motion on the switch to insure the contacts remain clean.

10. Tighten the two screws holding the switch bracket assembly (fig. 1C).
11. Remount the unit to the playfield and install the four screws removed in step 2.
