**SERVICE BULLETIN 1A
(Reprint)**

FROM: Pete Gustafson, Field Service Mgr.
TO: Service Managers
DATE: April 12, 1988
RE: Secret Service - Cross Playfield Plunger Shot

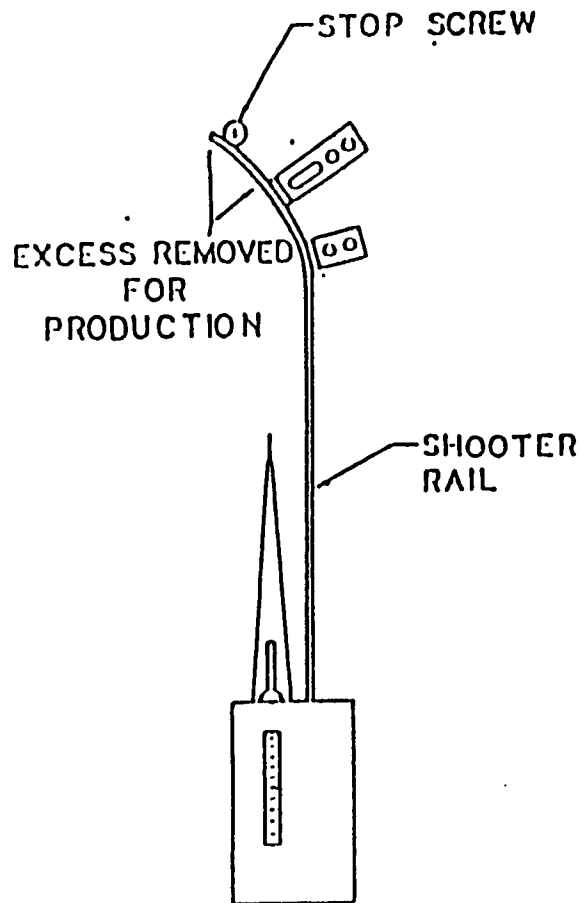
FIG. 1

1. The cross playfield shot from the ball shooter is adjustable, but may require premature adjusting due to the excessive length of the shooter ball rail. We have added a hole to the adjustable rail mounting bracket and the rail has been shortened (shown in Fig. 1) for the remainder of production but a stop screw should be installed behind the rail once it is adjusted properly.
