TECHNICAL BULLETIN

POINT BLANK 2

Two problems have been identified on games with the following serial numbers:-

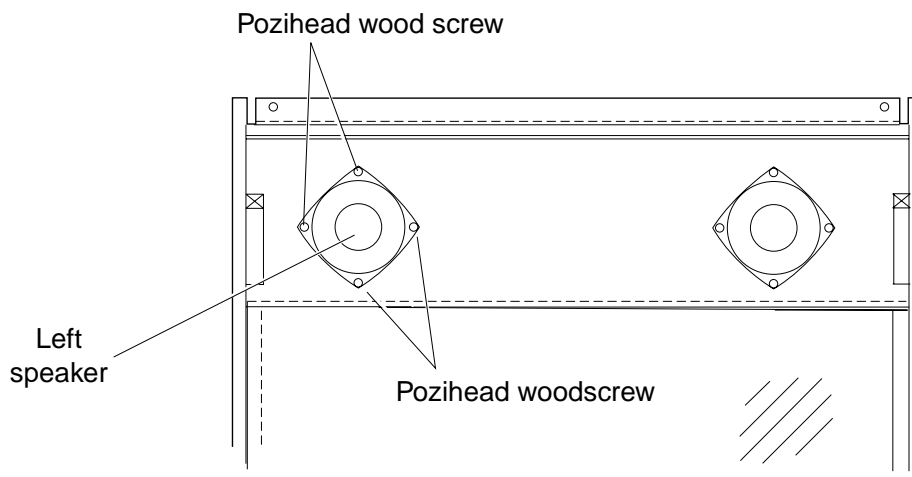
The loudspeakers have been wired 'out of phase' resulting in a loss of bass tone.

3. Remove 4 off pozi head wood screws and remove the left speaker only sufficiently to access the speaker connections.
Note: Take care not to damage the speaker cone.

4. Disconnect the speaker.
5. Cut off the 0.110" (smallest) receptacle from the white/violet wire and replace it with the supplied 0.187" receptacle.
6. Cut off the 0.187" receptacle from the white/red wire and replace it with the supplied 0.110" receptacle.
7. Reconnect the speaker and reassemble in reverse order.

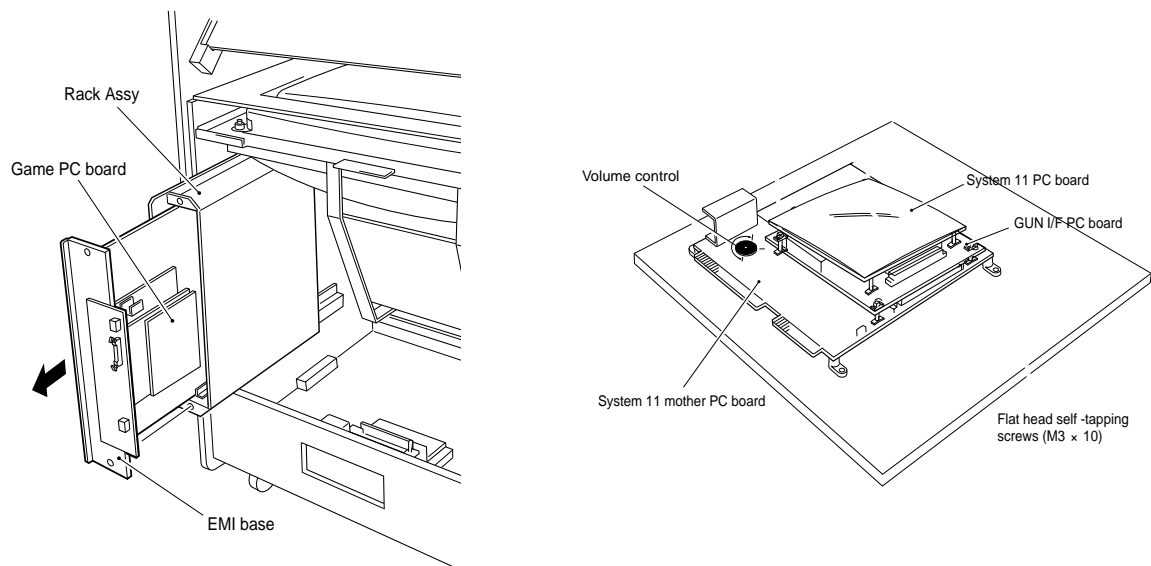
The master volume has been set too low.

10. Carefully withdraw the game pcb assembly from the rack assembly only sufficient to gain access to the volume control on the System 11 Mother PC Board.

11. Turn the volume control clockwise to approx $\frac{3}{4}$ of its travel.
12. Ensure that the System 11 Mother PC Board edge connection is fully seated in the edge connector housing of the EMI PC Board and reassemble in reverse order.
