SERVICE TIPS

GAME: COLONY 7

SUBJECT: SOME 74161 ARE NOT FAST ENOUGH FOR VIDEO COUNTER

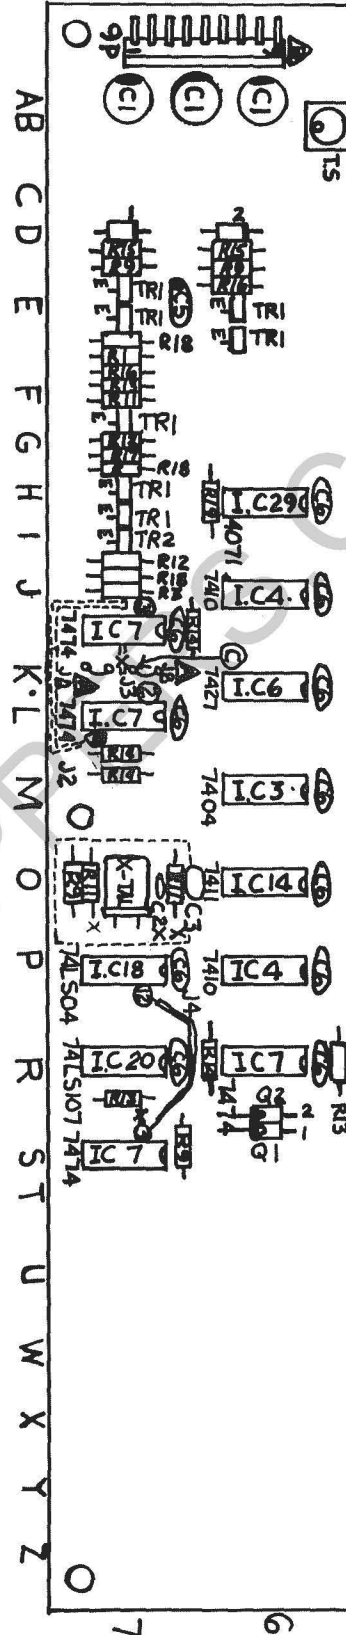
SUBJECT: FRAGMENT OF EXPLOSION STAYS ON THE SCREEN. FALSE END OF GAME.
IF YOUR HAND GETS NEAR THE CRYSTAL THE VIDEO WILL BE DISTORTED.

SOLUTION: STABILIZE TIMING CIRCUIT BY CHANGING VALUES OF FEEDBACK
RESISTOR.

PROCEDURE: REPLACE THE TWO (2) RESISTORS (R11) AT LOCATION O7 ON THE CPU BOARD, REFER TO FIGURE 1. WITH TWO (2) 470 OHM RESISTORS. THEN CHANGE THE 22pf CAPACITOR AT THE SAME LOCATION, WITH A 180pf CAPACITOR.

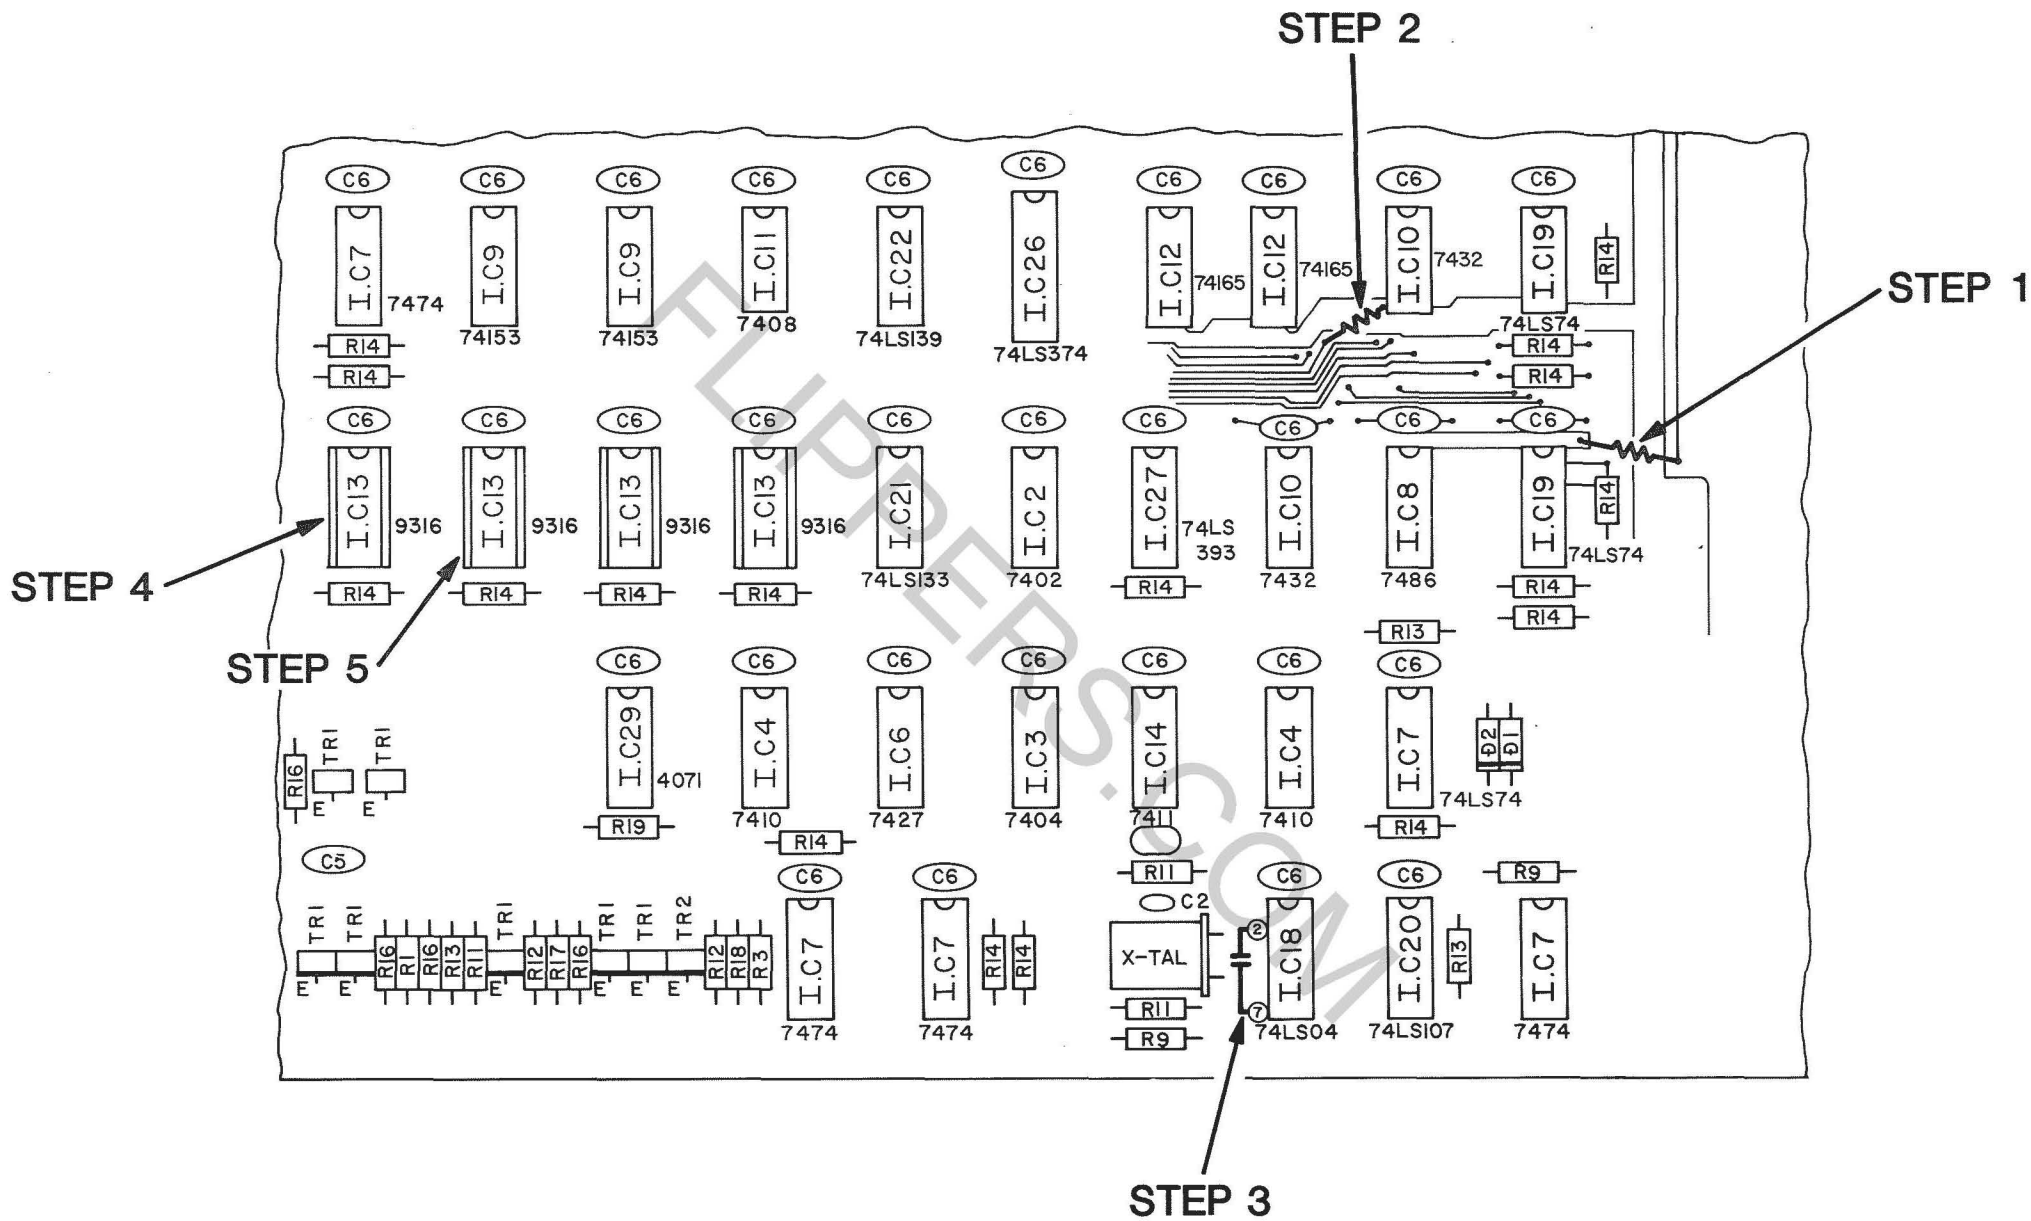
SUBJECT: DOT ON SCREEN OR INTERMITTANT FREEZE-UP

IN SOME CASES, A 220pf CAPACITOR WILL NEED TO BE ADDED TO THE IC
AT LOCATION 7P BETWEEN PINS 2 AND 7 AS SHOWN IN STEP 3 IN FIGURE
1. THE 74161 AT LOCATION 5E (STEP 4) CAUSES TEARING IN PICTURE,
PICTURE ROLLING, OR IT WILL CAUSE A RESET.

THE 74161 AT LOCATION 5F (STEP 5) CAUSES HORIZONTAL SYNC PROBLEMS.

SOLUTION: IMPROVE MULTIPLEXING TIMING CIRCUIT BY ADDING PULL UP
RESISTORS TO CAS AND A PULL DOWN RESISTOR TO RAS.

PROCEDURE: FIRST DO THE MODIFICATION STATED IN SERVICE TIP 81-5.
IN ADDITION TO THAT PROCEDURE ADD A 2.2K OHM RESISTOR TO THE CAS
ETCH AS POINTED OUT IN FIGURE 1 AS STEP 1.

IF PART OF THE LETTERING IS MISSING OR SOME DOTS ARE STILL ON THE
SCREEN ADD THE 2.2K OHM RESISTOR TO THE RAS ETCH AS POINTED OUT IN
FIGURE 1 AS STEP 2.

WHEN THESE 74161 CHIPS NEED TO BE REPLACED, PLEASE USE 74161 BY
SIGNETICS.

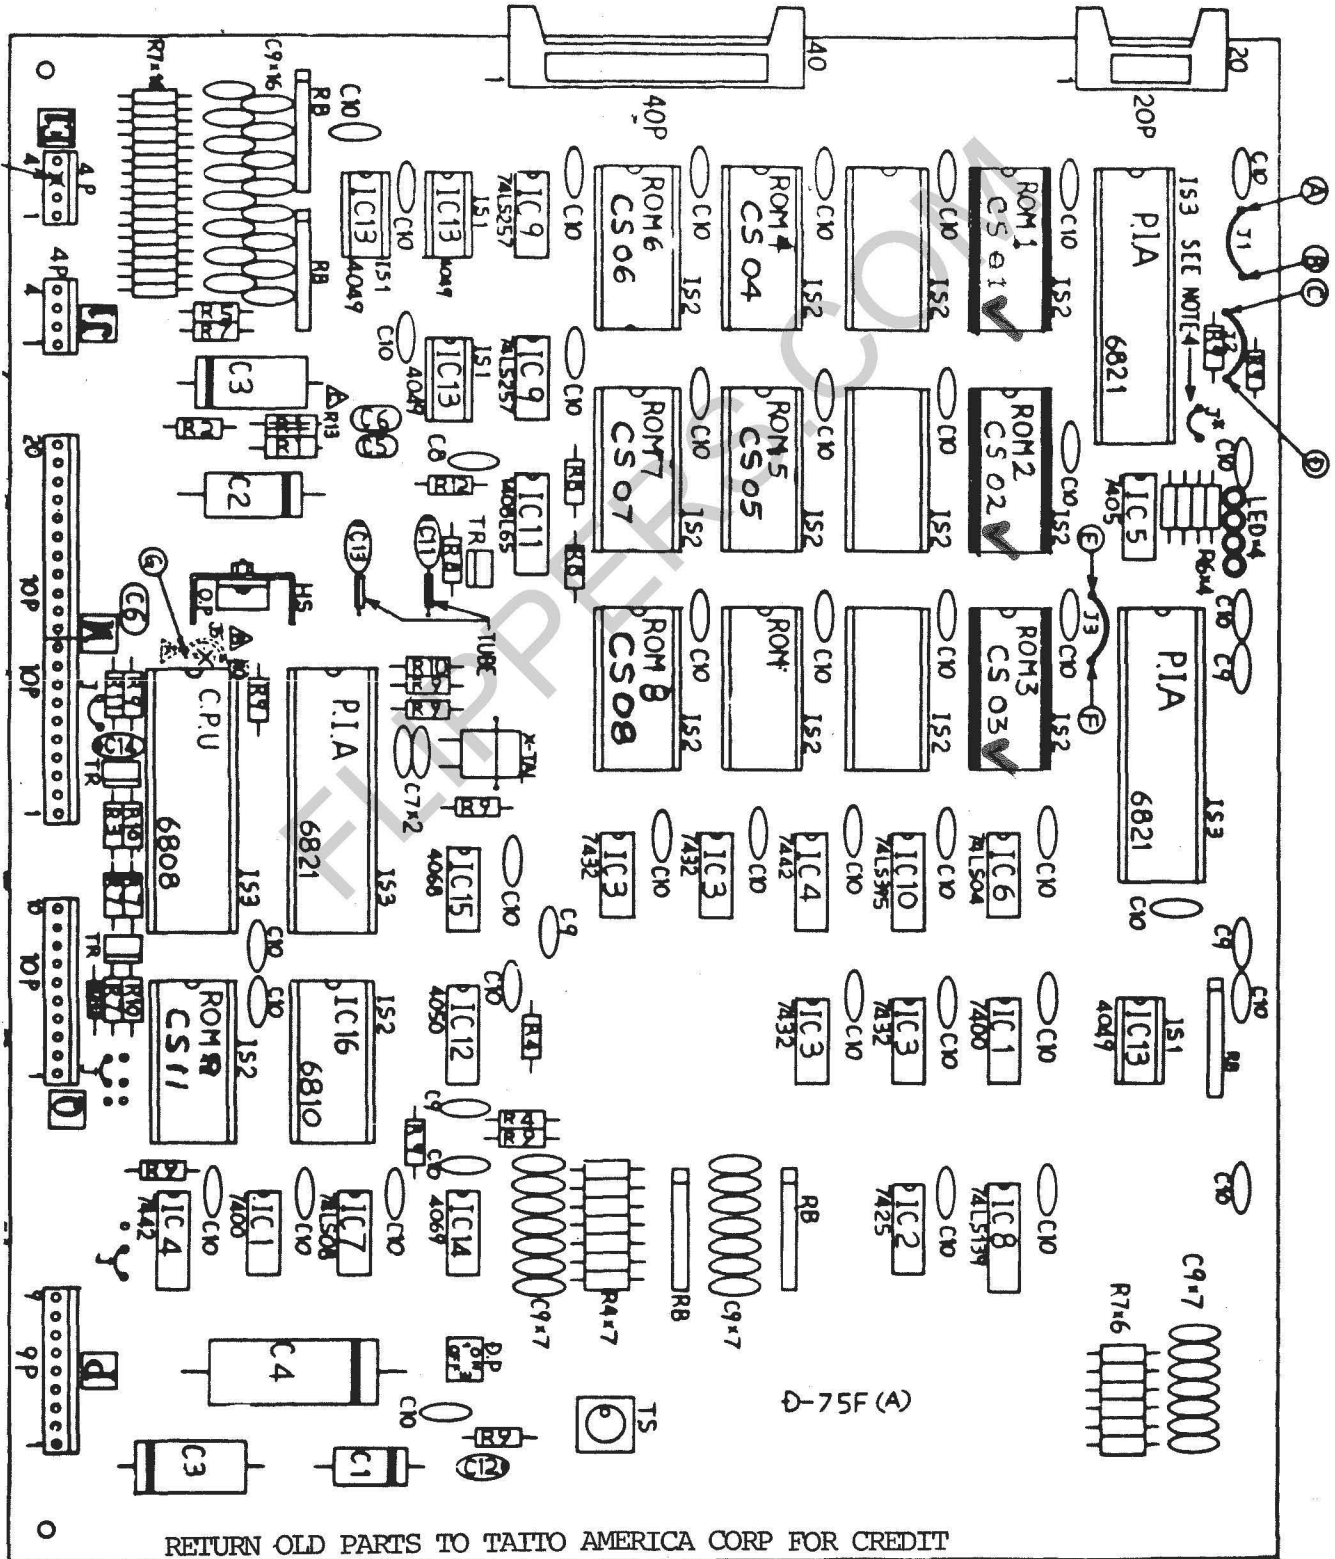
PROBLEM: PUTTING COIN IN DURING ATTRACT MODE DOES NOT ALWAYS PRODUCE CREDIT

SOLUTION: CHANGE ROM'S CS01, CS02, CS03 PER ILLUSTRATIONS

REPLACE CS01 WITH 16-00003-011, CS02 WITH 16-00003-012, AND CS03 WITH 16-00003-013
