Subject : Conversion of Pole Position II boards from Japanese to English.

Subject: Pole Position M.O. Problems

To: Darl Davidson  
From: Sam Deus *Sam*  
Subject: Pole Position P.C. Board Problems

# Pole Position Video Board Manufacturing Defects

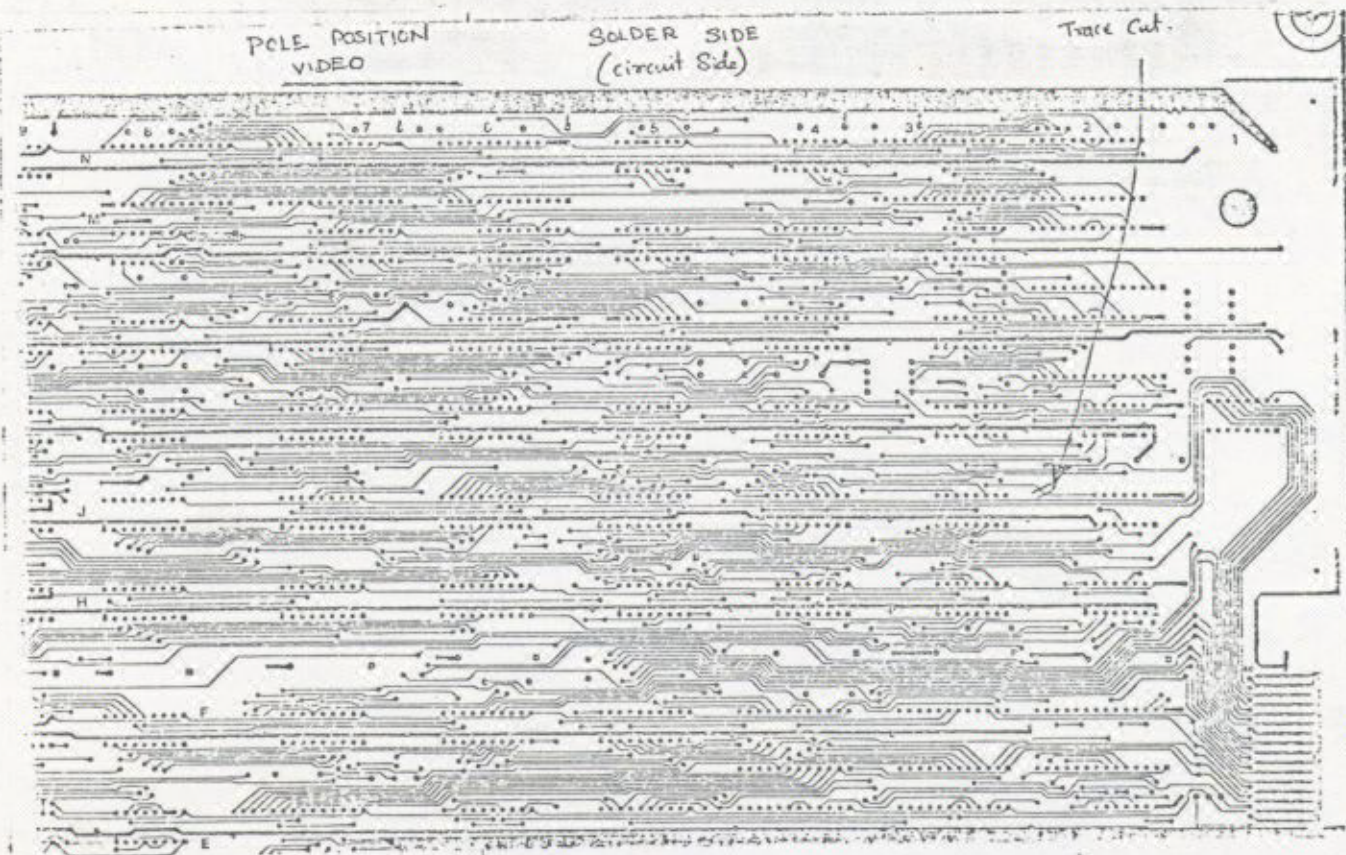
The principle problem with the Pole Position Video boards was a masking error; VSYNC was being disrupted by a signal which was being output from pin 8 of IC 2J. Pin 8 of 2J had to be cut & lifted from the feed thru pad because the VSYNC trace was erroneously masked & subsequently etched from pin 17 of IC 2F (custom IC 07) to pin 8 of IC 2J (74LS10) which is supposed to be an unused output, not an input. See page 3 of 10 (Video PC BD schematics)
