# Service Bulletin N° 97

DATE: April 8, 1997

SUBJ: X-Wing Motor Bushing

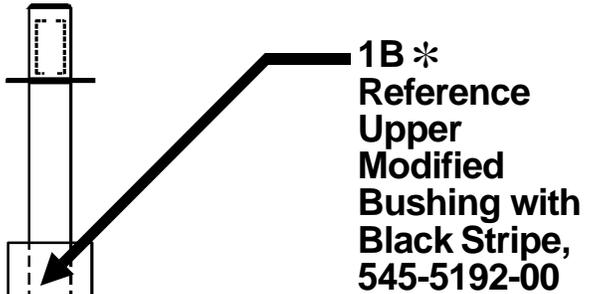
Fig. 1

Due to slight variances in spotting the X-Wing Assembly while mounting it to the playfield, the shaft bushings (**See Fig. 1**) can cause some binding to the motor shaft. Increasing the inside diameter of *either* shaft bushing (**See Fig. 1A & 1B**) will correct this problem. For simplicity in this correction we recommend fixing the bottomshaft bushing (**See Fig. 1A**). (**See Note below.**)

As stated, there are 2 X-Wing Shaft Bushings, one (1) on the X-Wing Motor Assembly (**See Fig. 1A**) and one (1) on the Upper Motor Shaft on the playfield side (**See Fig. 1B**). **All games made after Serial N° 138041 have been modified and should not experience this "stuck-state" symptom.** The bushing mounted on the playfield side will have a black stripe indicating this (**See Fig. 1B**). **Unless your game is experiencing the above symptoms disregard the above procedure.**

The manual pointed to the wrong bushing. The bushing referenced, 545-5783-00, is mounted on the bottom end of the motor shaft next to the motor. The upper bushing the "manual points to" is 545-5192-00 & is not included with the X-Wing Motor Assy., 500-6175-00-56.

\* Note:  
If the Upper Bushing has a black stripe, you should not experience any "stuck-state" symptom and no further update procedure should be required.

- ① Locate the X-Wing Motor Assembly Bottom Shaft Bushing, 545-5783-00, on the bottom side of the playfield (**See Fig. 1A**).
- ② Locate and remove the Retaining Clip (E-Ring), 270-5002-00, located at the base of the X-Wing Shaft (**See Fig. 1C**).
- ③ Remove the three (3) #6-32 X 1/2" HWH TF Mounting Screws, 237-5924-00, securing the Bushing to the X-Wing Motor Bracket (**See Fig. 1D**).
- ④ Remove the Bushing from X-Wing Motor Bracket (**See Fig. 1A**). Using a #G or a 6.6mm Drill Bit, enlarge the existing Bushing Shaft Hole. Reassemble.

If you do experience the "stuck-state" symptom, simply remove the bottom shaft bushing (removal of the Retaining Ring & 3 Screws is required) and drill the existing Shaft Hole with a #G or 6.6mm Drill Bit and reassemble.
