SERVICE BULLETIN

SEGA BASS FISHING UPRIGHT

PROBLEM: The Handle for BASS Fishing's Upright Cabinet is breaking due to abusive load/torq applied to the Handle Assy.

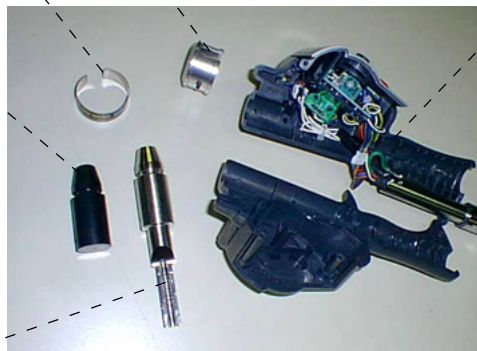
ROD TIP (OLD)

Reinforced Metal ROD TIP (NEW)

SOLUTION: The Handle Assy can be refitted with a support tube capable of dispersing the force exerted on it by customers in the field.

- 5 Next cut away a ribbed portion of the Handle Assy as shown in photos ABOVE to allow enough room for the new piece to be installed.
- 6 Replace the black Rod Tip with the reinforced metal Rod Tip.
