**FIELD MAINTENANCE GUIDE
BULK-LOADED DOLLAR BILL CHANGERS**

ARDAC

SYSTEM DESCRIPTION

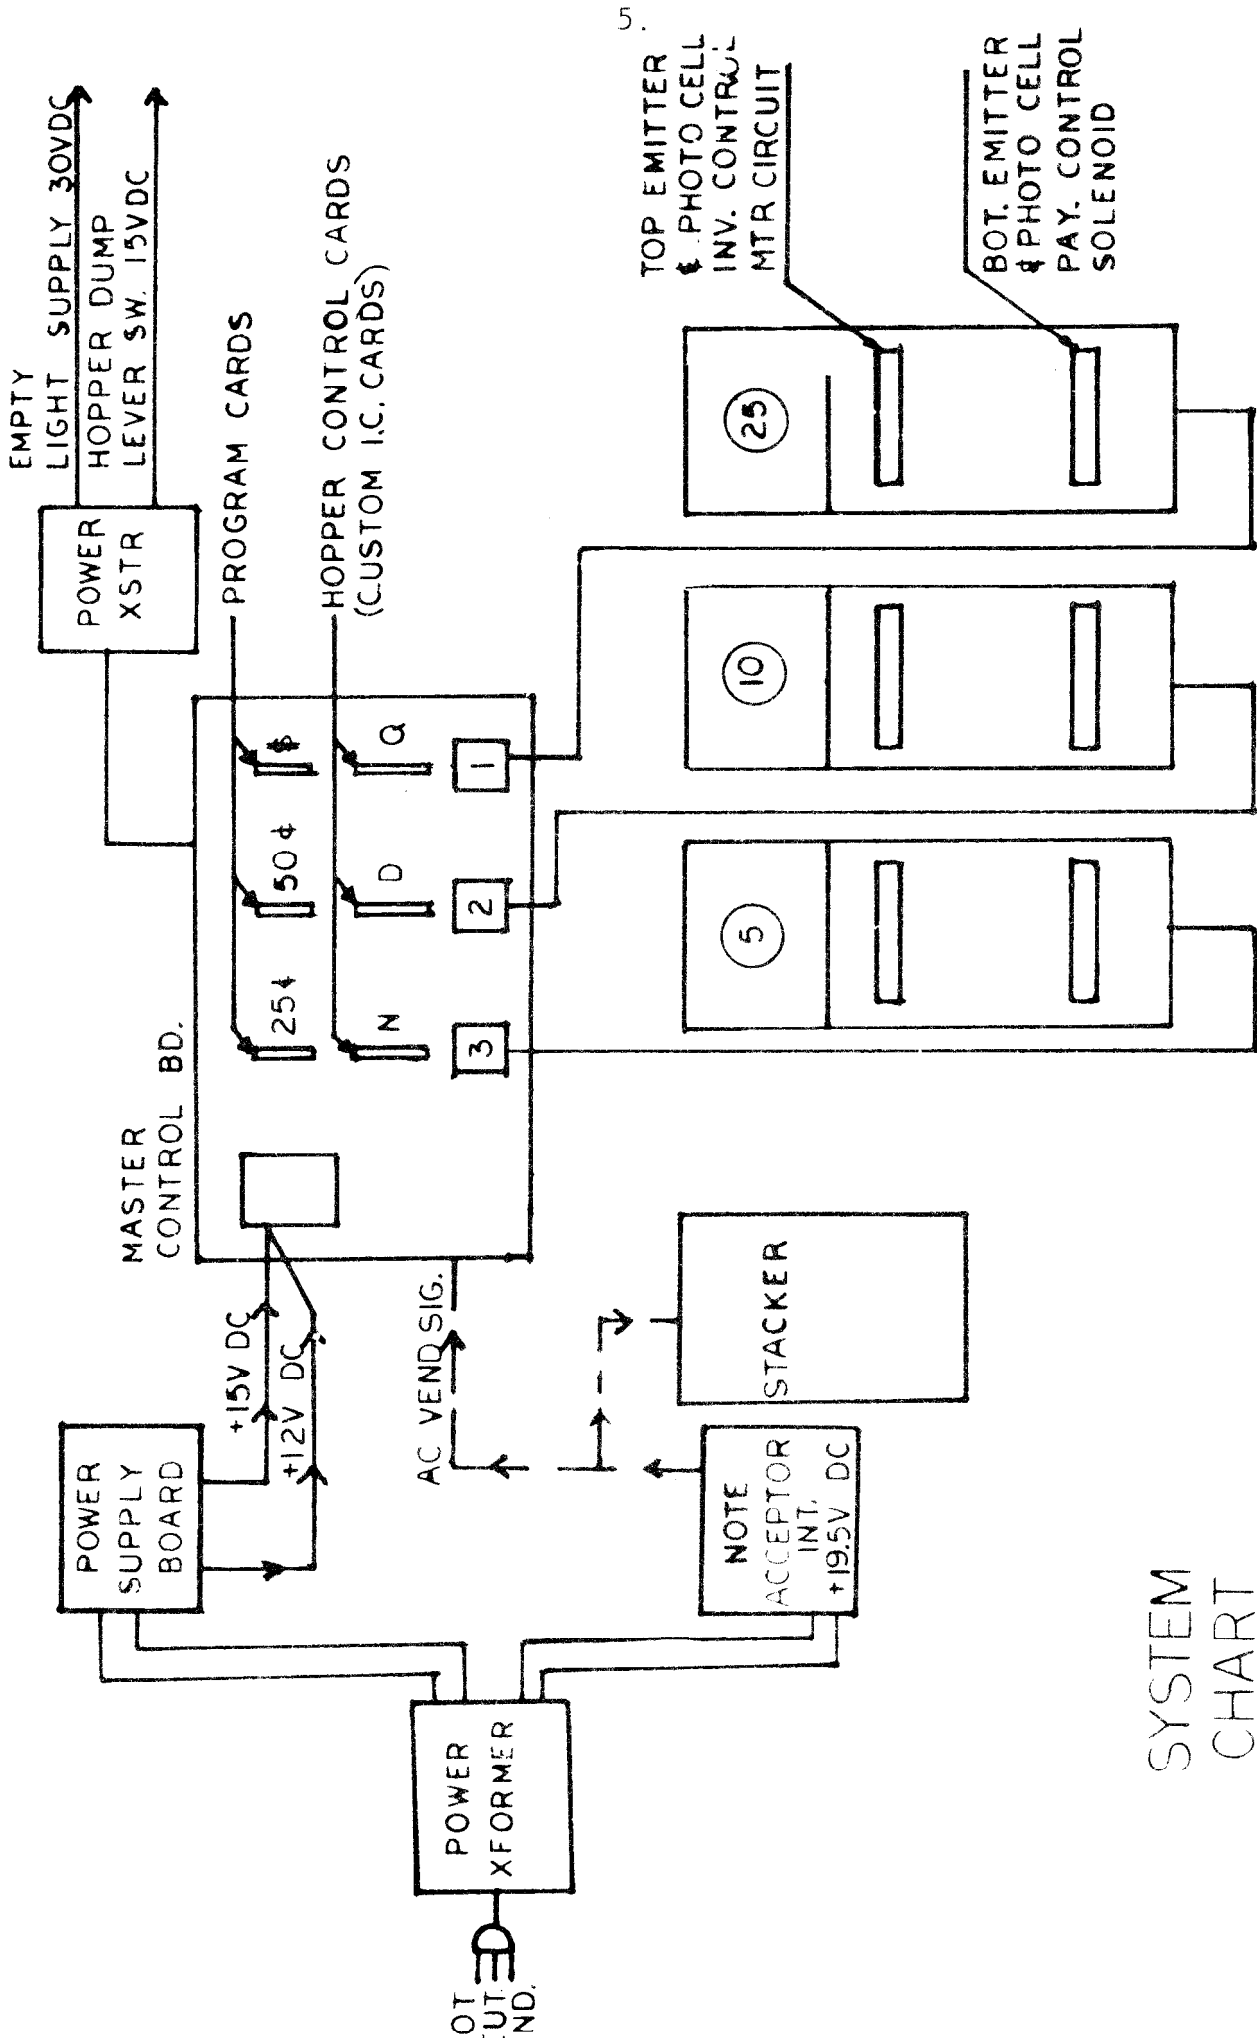
Figure 1 shows a simplified block diagram of the changer components.

SYSTEM CHART

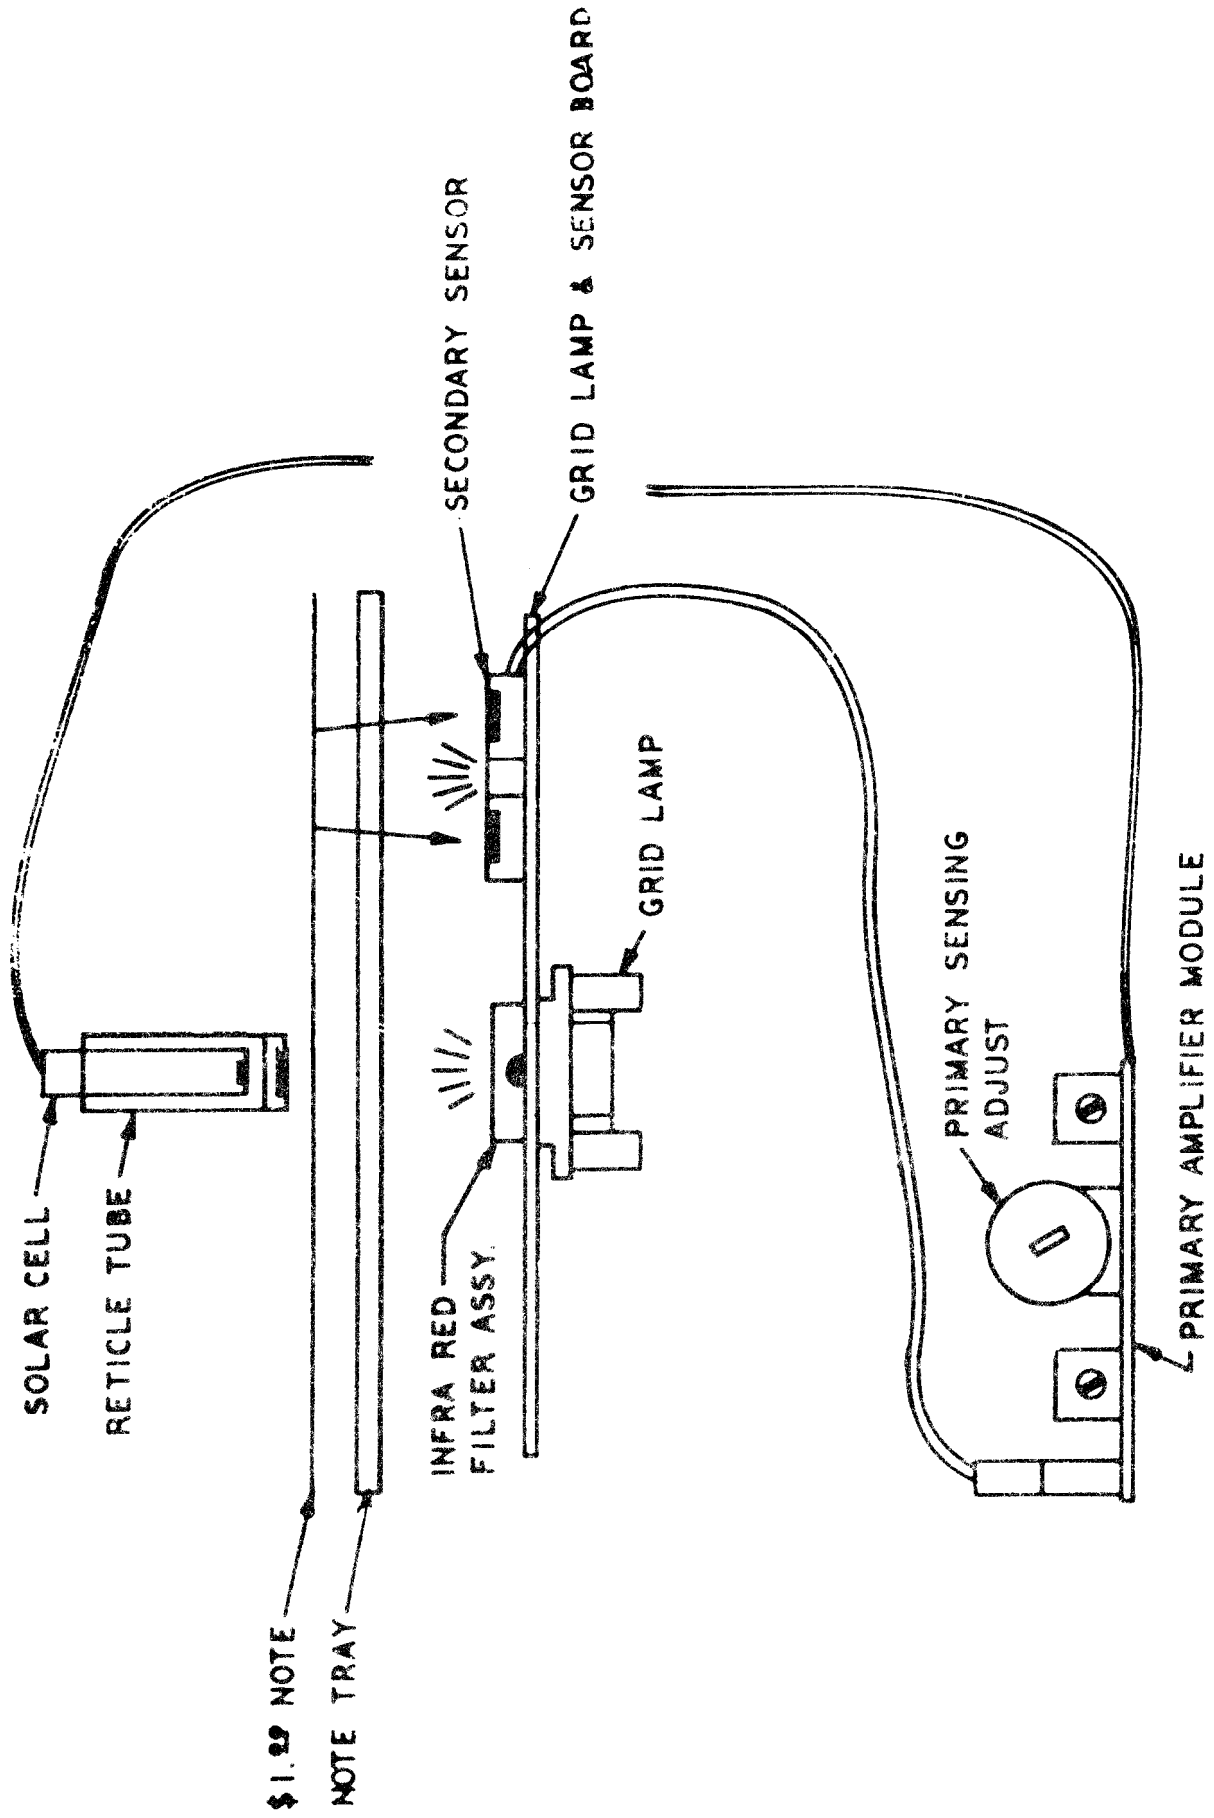
Figure 2

PRIMARY SENSING

1. Primary Detection. This system scans the top side of a note. It examines the grid pattern engraved around the portrait area to determine the correct pattern and characteristics of the ink. It consists of a reticle tube and solar cell on top of the tray insert, and a grid lamp and infra-red filter assembly under the tray. These items are shown in Figure 2.
2. Secondary Detection. This system looks at the back of a note. It is a self-contained reflective sensor. It is also shown in Figure 2.

Using a soft cloth or pipe cleaner, carefully clean any dirt, grime or smoke that has accumulated on the tray insert and the housing of the secondary sensor (Figure 2). Using a soft brush, carefully remove any dirt or dust that has accumulated in the infra-red filter assembly over the grid lamp. Make sure smoke is cleaned from the top and bottom of the tray insert.

<u>Problem</u>	<u>Probable Cause</u>	<u>Corrective Action</u>
Changer will not accept bills.	Faulty component in changer.	Disconnect stacker and plug cabinet harness directly to the note acceptor. If unit now accepts, replace defective stacker. Turn main power off. Remove the clear plastic inhibit relay from the power supply board. Turn power on. If unit now accepts, the problem is a Hopper control board, hopper or harness. These components should be operated one at a time to isolate defective one.
	Secondary detection system in note acceptor out of adjustment.	Disconnect sensor plug J5 (Figure 3). Test unit. If unit accepts bills, adjust secondary detection system (Page 9).
	Sensing module loose.	Make sure amplifier module (Figure 2) is inserted properly and making good contact.
	Defective grid lamp.	Remove top plate of acceptor. Lift tray clear switch. If a red light does not appear under the infra-red filter (Figure 2), replace grid lamp.

Broken wire to solar cell.	Check wires (Figure 2) and replace solar cell if wires are broken.
Changer will not accept coins.	Loose connection to coin acceptor.	Make sure plug is connected to coin acceptor.
	Defective block-out coil.	Make sure block-out coil activates when changer is turned on.
	Faulty component in changer.	Follow same procedure described for non-acceptance of bills.

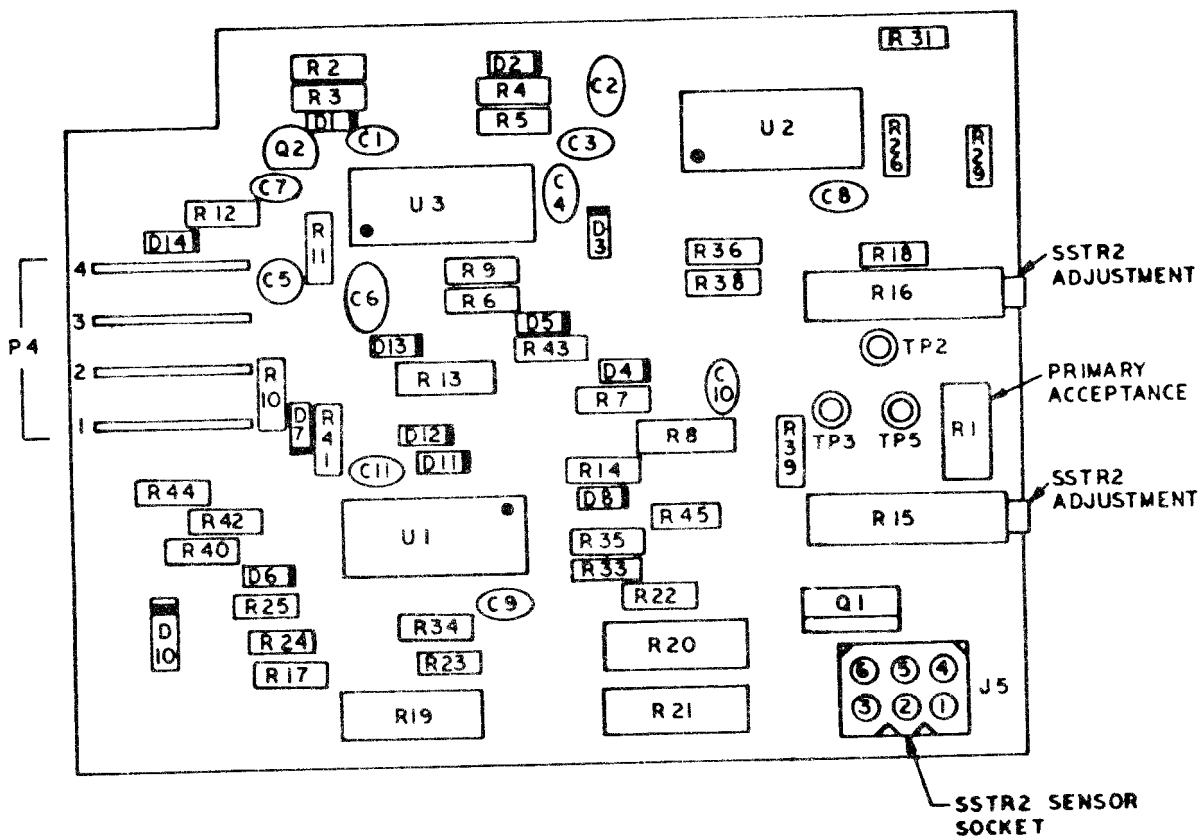
Figure 3

Adjustment of the primary detection system is made by turning the primary acceptance control, R1, which is located on the amplifier module board (Figure 3).

1. Disable the Secondary Detection System by unplugging the SSTR2 sensor, plug J5 (Figure 3).
2. Turn the primary acceptance control fully counter-clockwise.
3. Adjust the primary acceptance control by turning it in a clockwise direction until

The secondary detection system adjustments, R15 and R16, are also located on the amplifier module board (Figure 3).

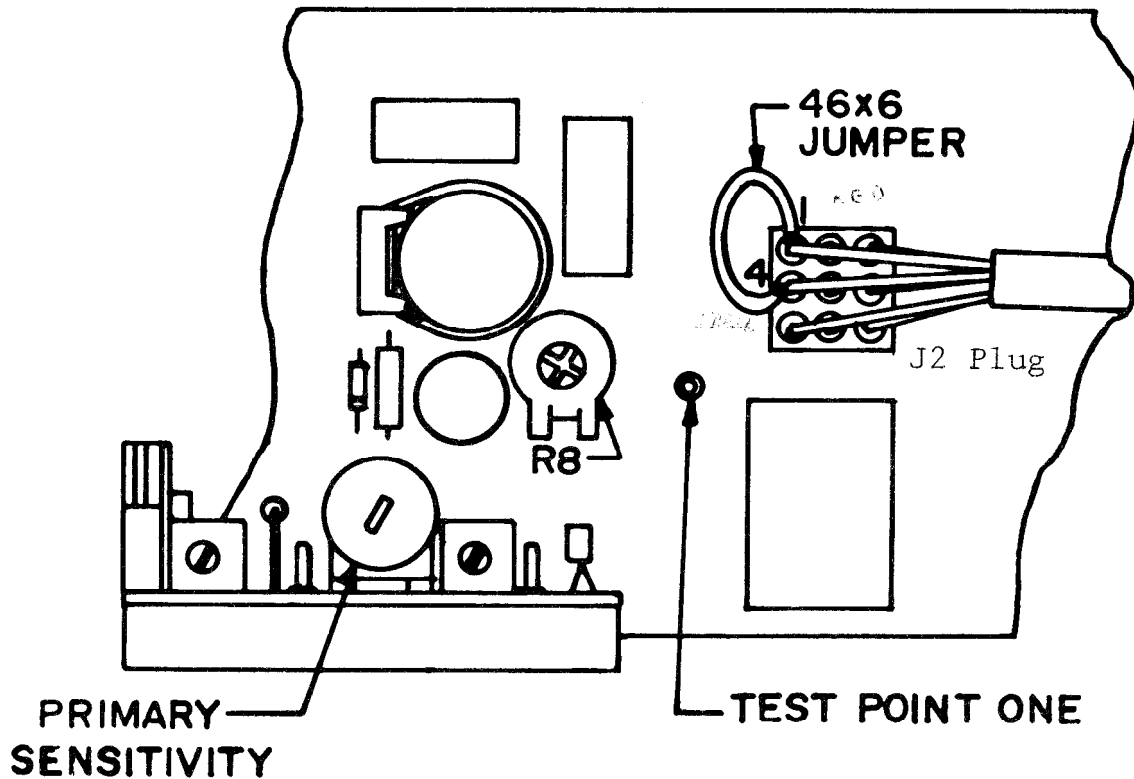
Figure 4

1. Place a jumper wire between pins 1 and 4 of plug J2 on the master board (Figure 4).
2. Turn potentiometer R8 fully counterclockwise. This potentiometer may have a Factory Sealed label over it which must, of course, be removed.
3. Connect your volt meter with the common lead to the acceptor chassis and the positive lead to test point one, TP1 (Figure 4).
4. Insert the adjustment card, 49 X 218, into the tray with the words "Clearing Circuit Adjustment" pointing towards the note acceptor but facing down. Close the tray and adjust potentiometer R8 for a reading of approximately .5 to .7 VDC (less than one volt).
5. Release the tray, remove the adjustment card and insert it with the words "Clearing Circuit Adjustment" away from the note acceptor facing down, side B. Close the tray and measure the voltage at TP1. This voltage must be equal to

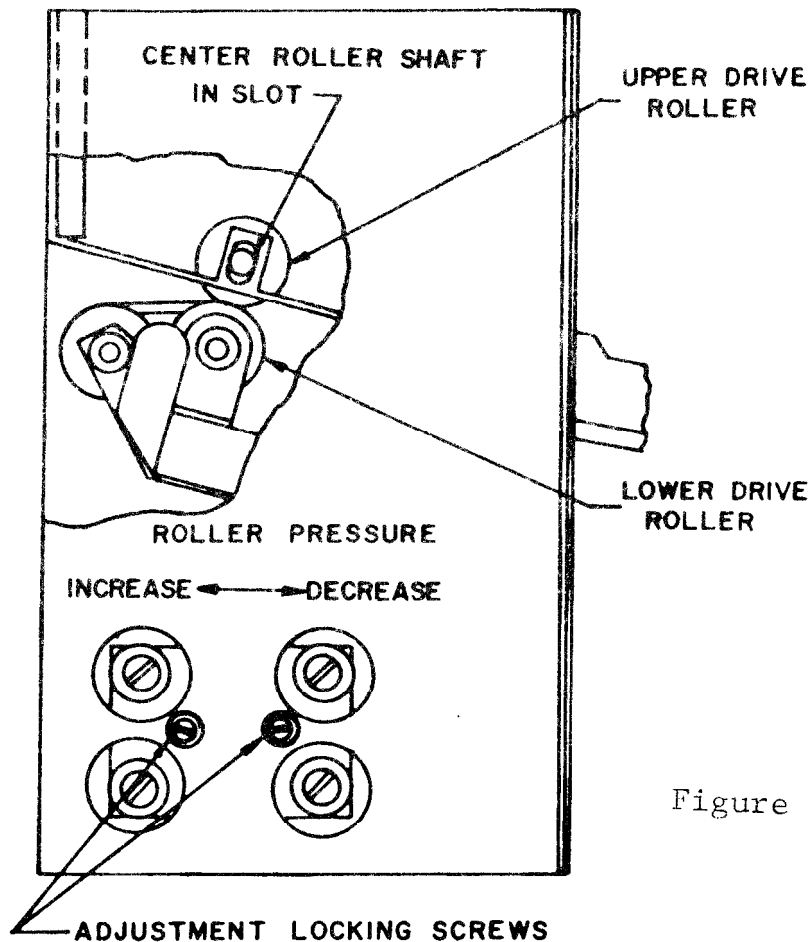
Figure 5

1. Solenoid Adjustment
 - a. Loosen the adjustment locking screws (Figure 5).
 - b. Move the solenoid fully right towards the front of the acceptor.

The note stops prevent improper placement of the note in the tray. They are the white plastic stops mounted on the rear of the tray assembly. When the tray is closed and the motor rail engaged, the note stops must be lowered below the surface level of the tray to allow the note to pass through the acceptor. This is accomplished with adjustable tabs on the motor rail. They can be re-formed up or down to increase or decrease deflection of the note stops.
