U3100 SERVICE BULLETIN

CAPACITOR ADDED TO CHASSIS

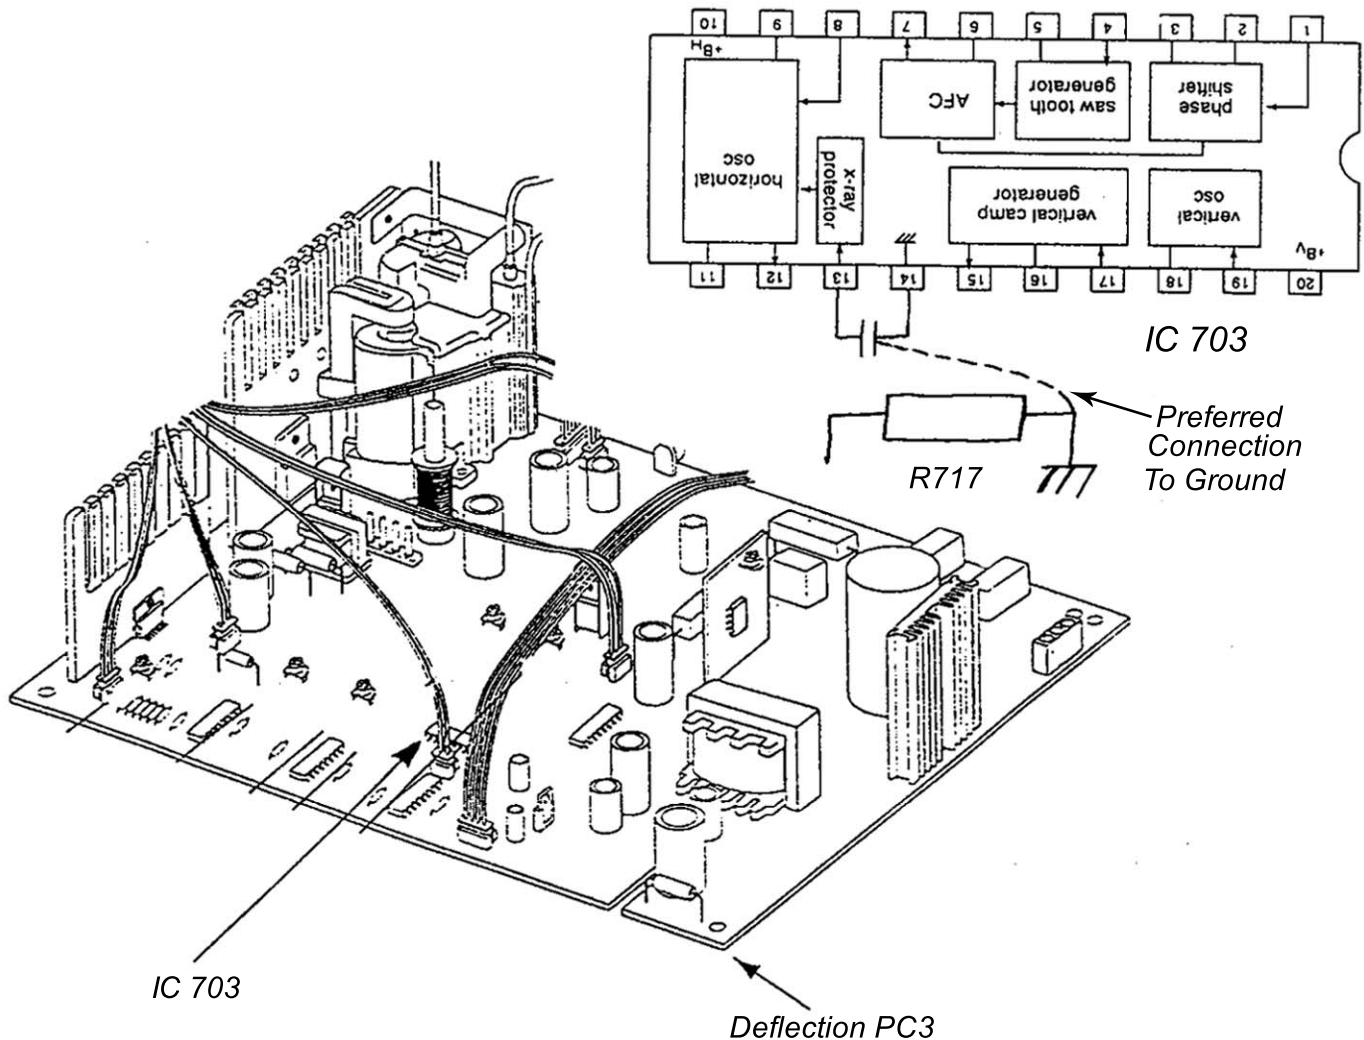
The monitor goes into a shut down mode after being powered on for a few hours. After recycling the power the monitor will operate for some time and shut down again.

The picture tube may arc and trip the high voltage shut down circuit. This will shut down the scan and there will be no light output on the screen.

Remove the chassis from the monitor and add a .68UF 63V capacitor (stack metal film type). The part number for the capacitor is 2DCMA1J684KT. Solder the capacitor either to pins 13 and 14 of IC703 or to pin 13 and the ground side of R717, which is on the left side looking from the back of the monitor.
