DATA EAST PINBALL, INC.

Service Bulletin #015

To: Service Manager
Date: April 6, 1989
Subject: Time Machine Ramp Modification

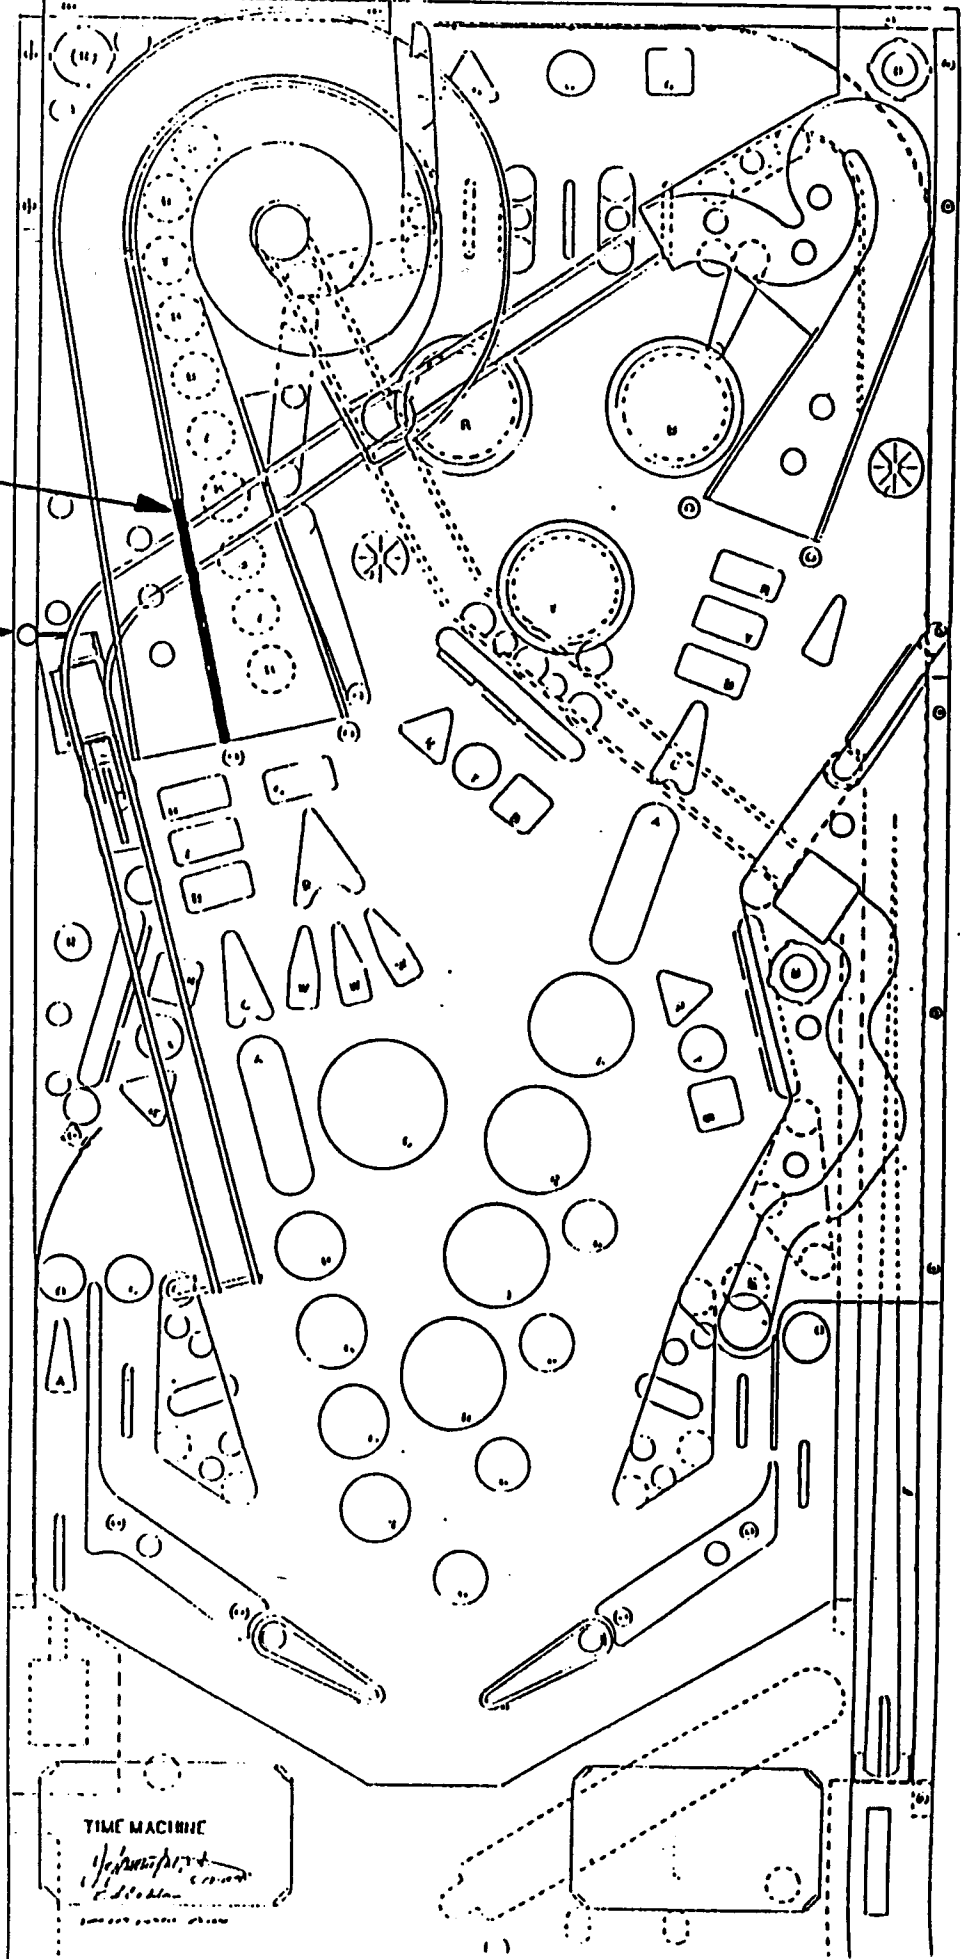
Problem: The divider between the left (Left Ball Lock Ramp) and center (Star Warp Shot) ramp breaks. This does not cause a serious operational problem but it does look bad.

Install
bracket
as shown.

Remove this
screw from the
metal cross
playfield
ramp support.

Solution: Enclosed Please find 10 metal "U" shaped brackets that snap over the center divider between the two ramps. It will protect the center divider from sideward hits from the pinball. No gluing or screwing is required to attach the bracket.

- 1) Remove the clear plastic that covers the ball lock micro switches.
- 2) Remove the cross playfield ramp retaining screw. (see diagram)
- 3) Gently lift the cross playfield ramp up so that the ramp protector bracket can be installed. (see diagram) The bracket snaps over the last 6 inches of the ramp.
- 4) Reassemble in reverse order.
